**REPORT ON**

**EXISTING SHORELINE, SEA DYKE AND  
SHORE PROTECTION WORKS IN VIETNAM  
LOWER MEKONG DELTA COASTAL ZONE  
AND  
ORIENTED SOLUTIONS FOR STABILITY**

**2/2017**

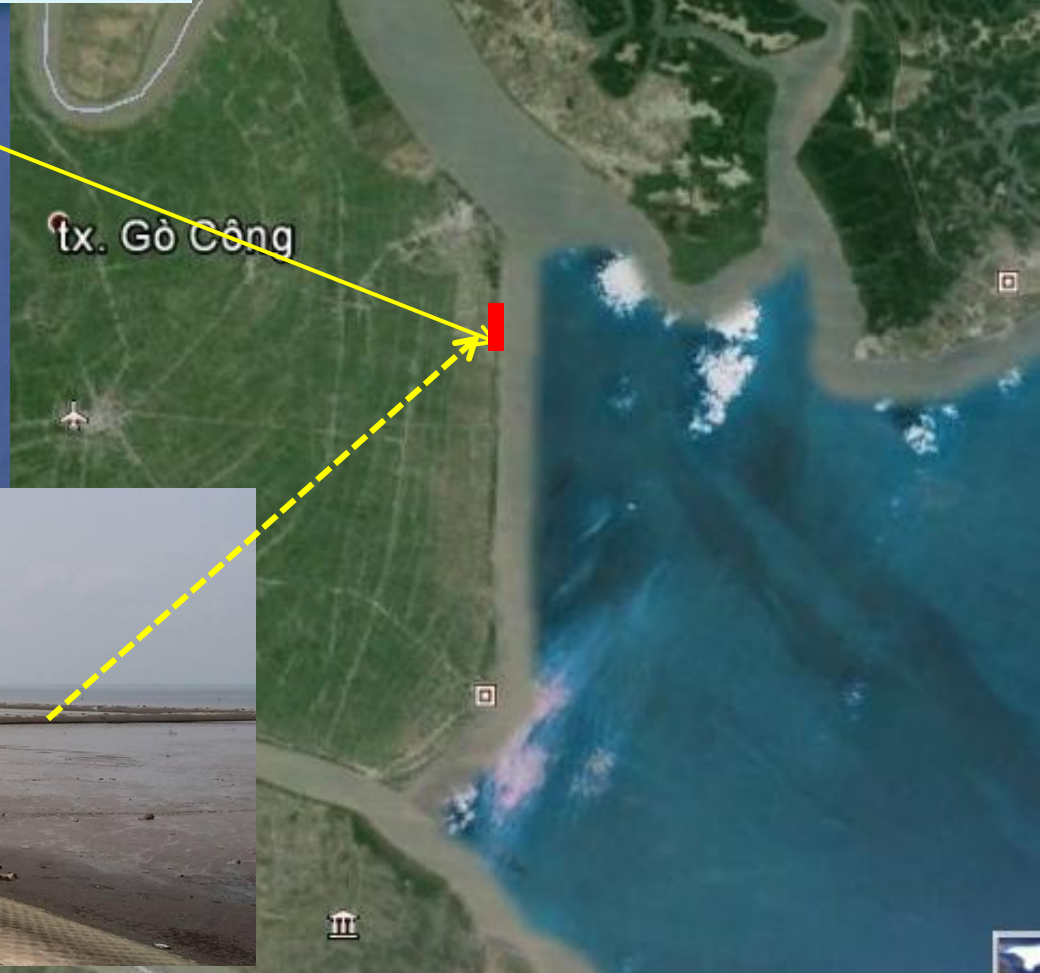
**G.3**

# 1. Tien Giang- GoCong Geotube breakwater (G3); L= 400 ? m

**Observation: it has just been constructed in 2016? It has to be monitoring for few years for evaluation (several NE monsoon seasons)**

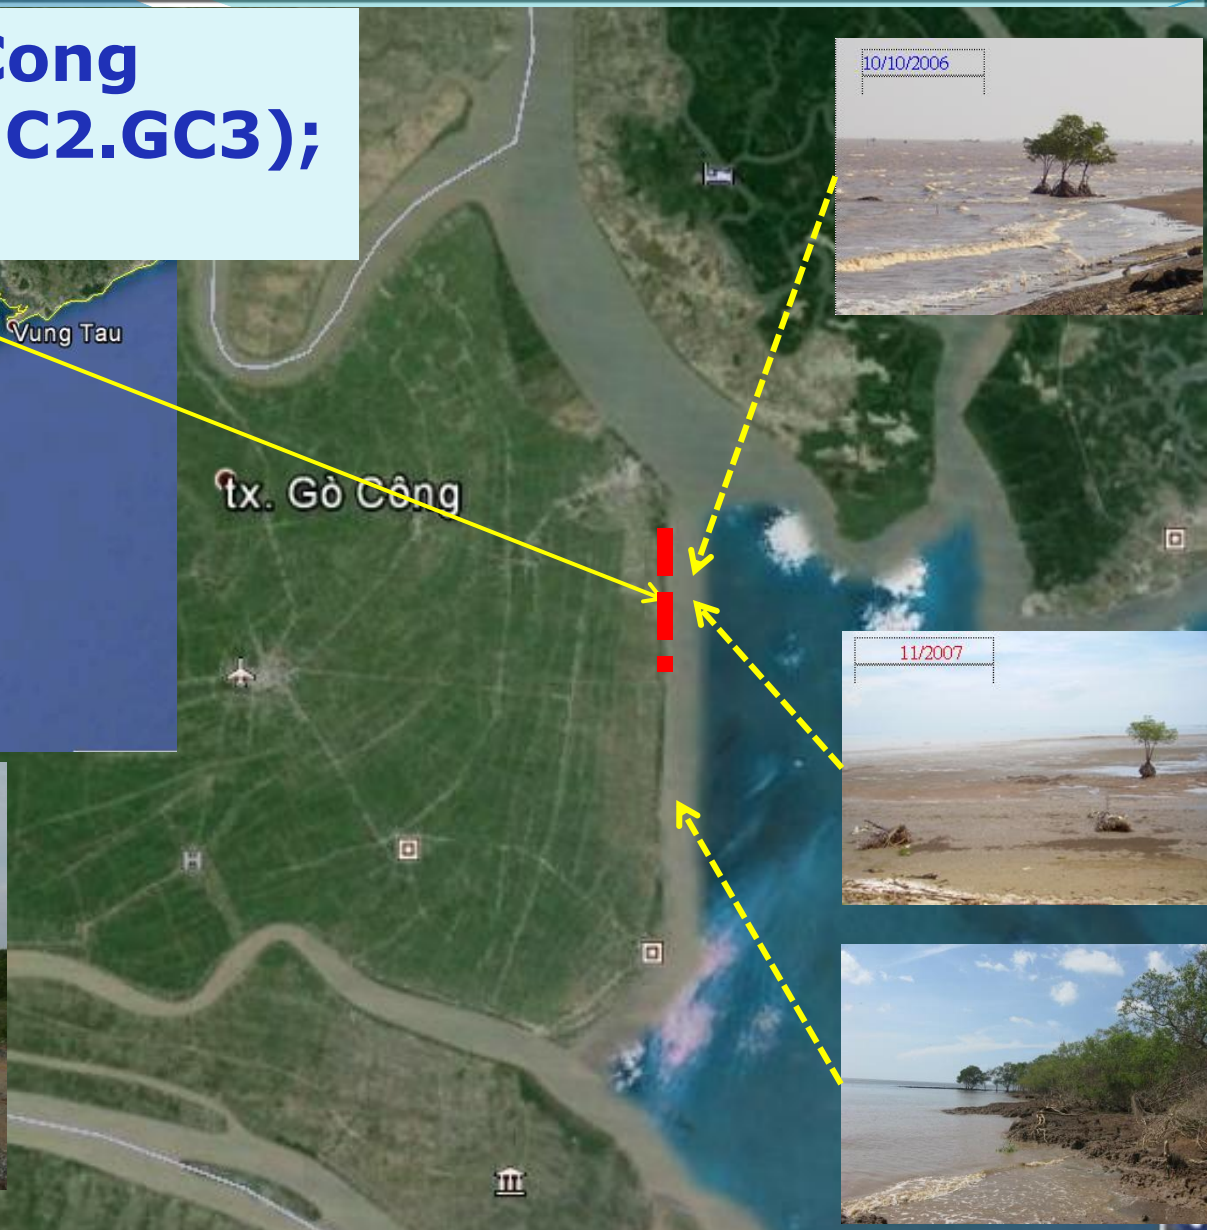
**K.1**

# 1. Tien Giang- GoCong Revetment (GC1.GC2.GC3); L= 5 Km

**Observation: Protected from erosion but no long-term guarantee due to there is no mangroves in the front, needed breakwater and mangrove rehabilitation**

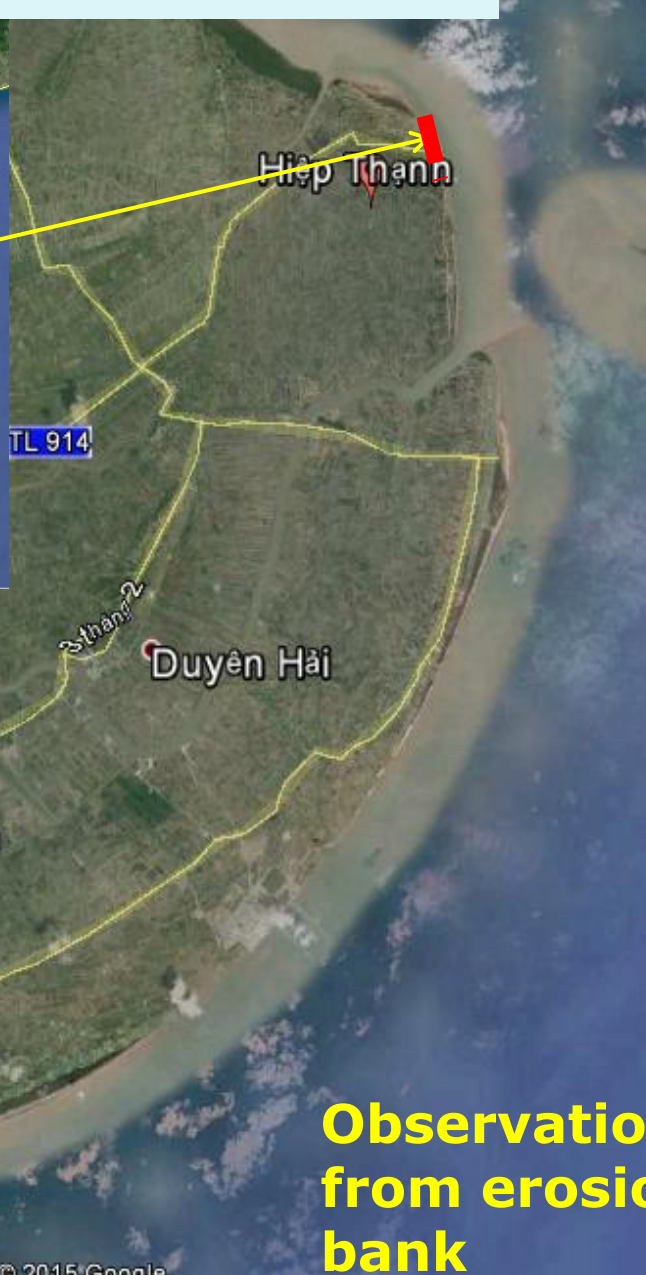
K.1

## 2. Tra Vinh- Hiep Thanh Revetment L= 1.325Km

Revetment built along old dyke line and new dyke set up - 150 m far from old dyke line - 2009

**Observation: Protected from erosion of sand bank**

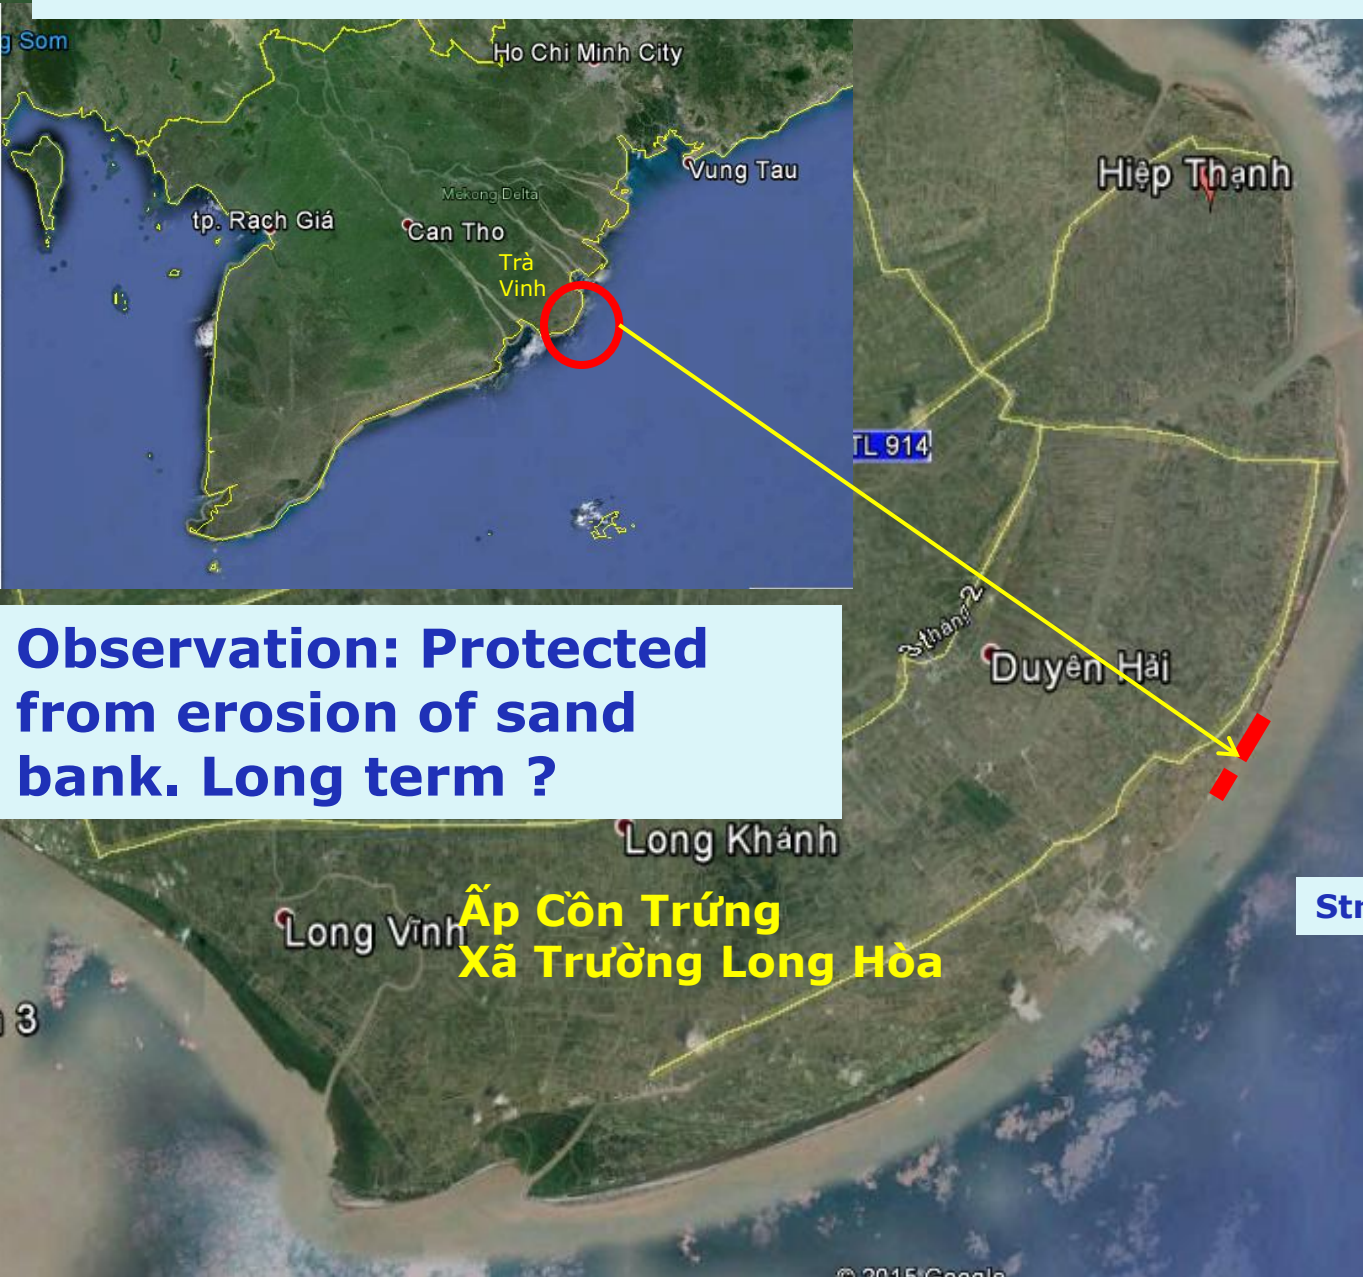
K.1

## 2. Tra Vinh – Con Trung Revetment– L= 750m

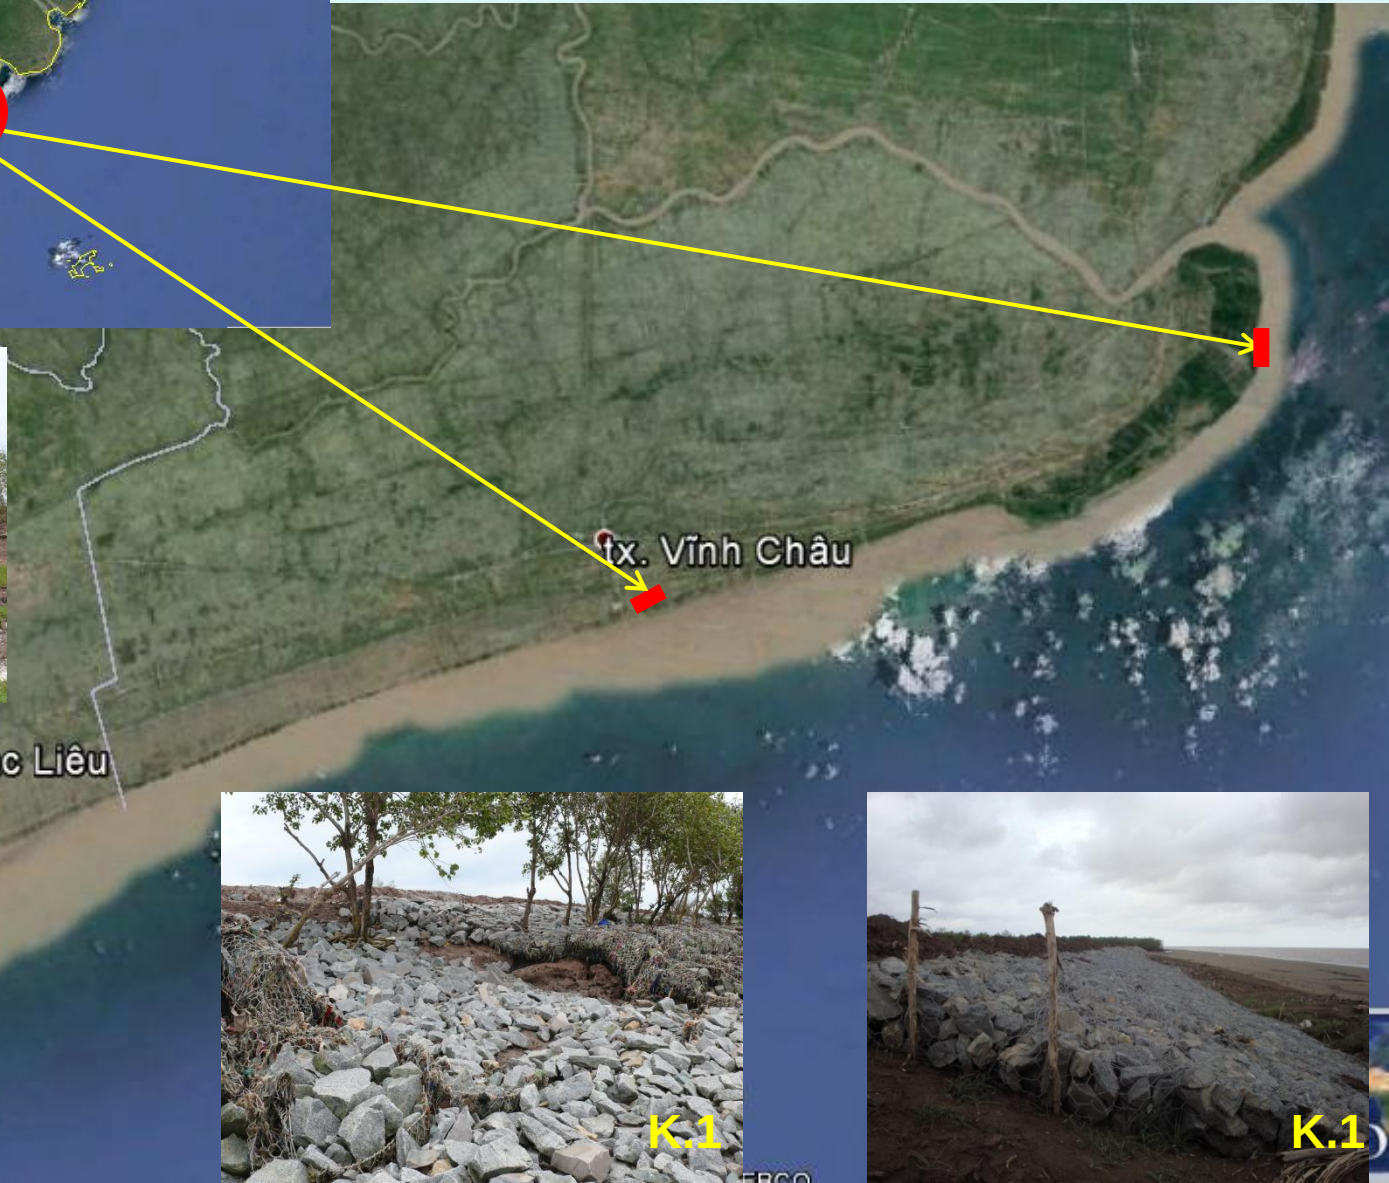
# 3. Soc Trang– Vinh Chau, Vinh Tan Revetments L= 0.58 Km

Observation: Toe erosion

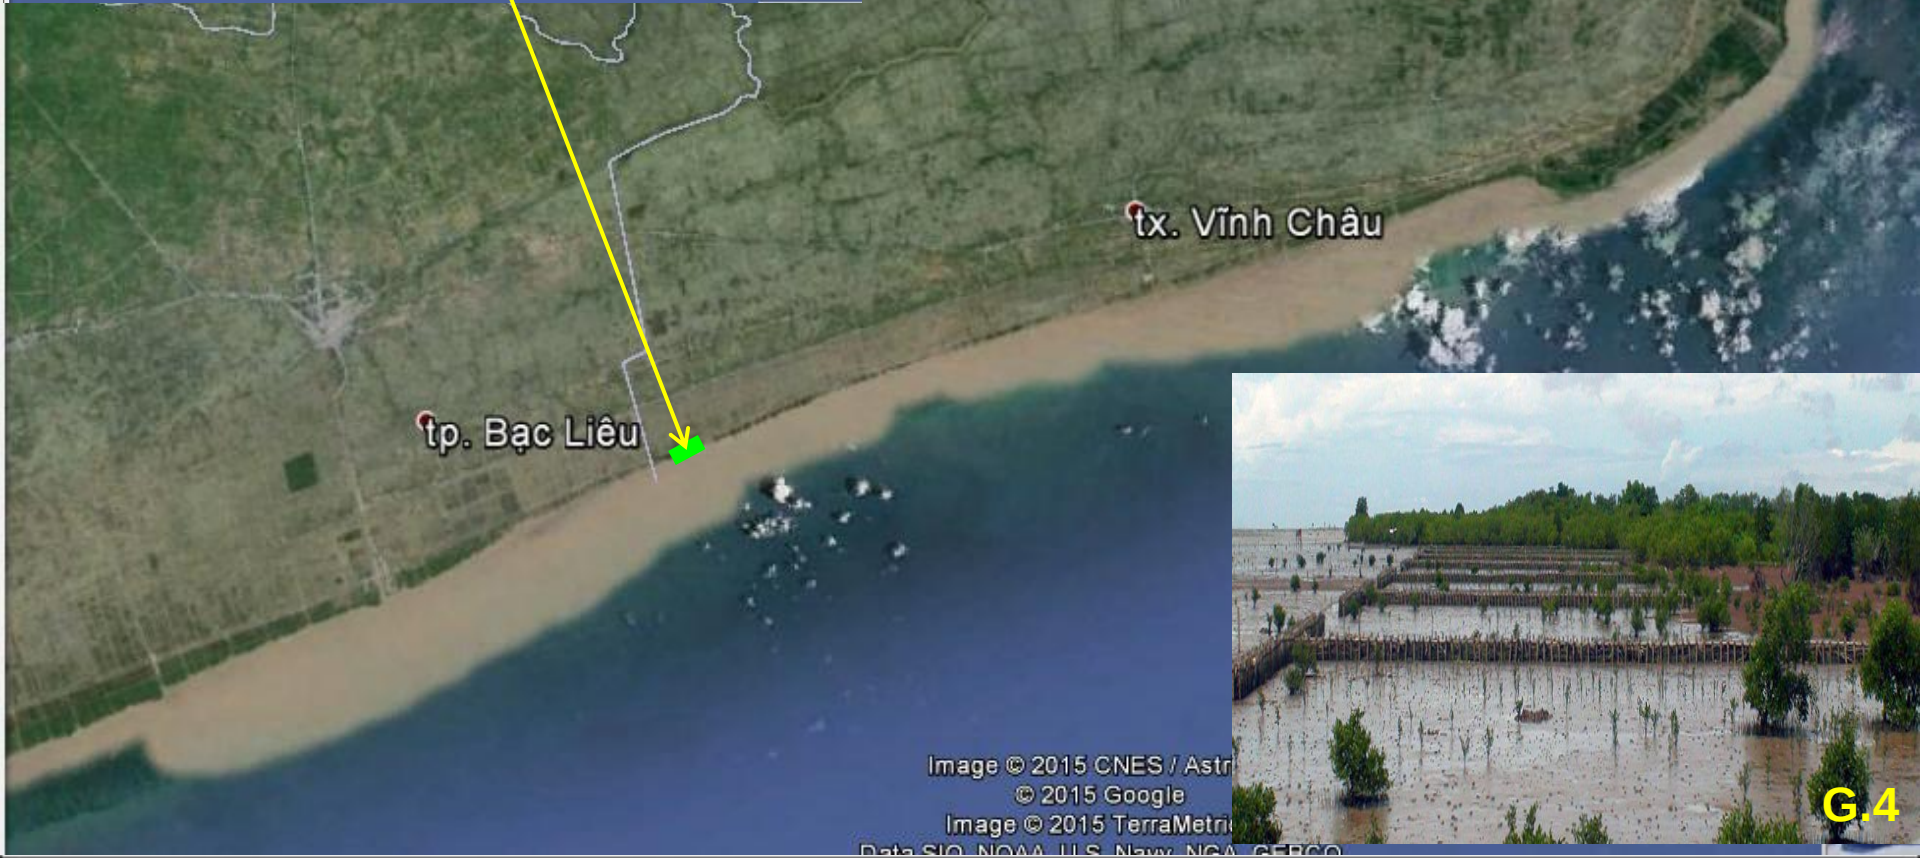
### 3. Soc Trang– Bamboo wave breaker and fence : L= 0.30 Km

**Observation : Effective deposition  
– low wave, short life (1 year?)**

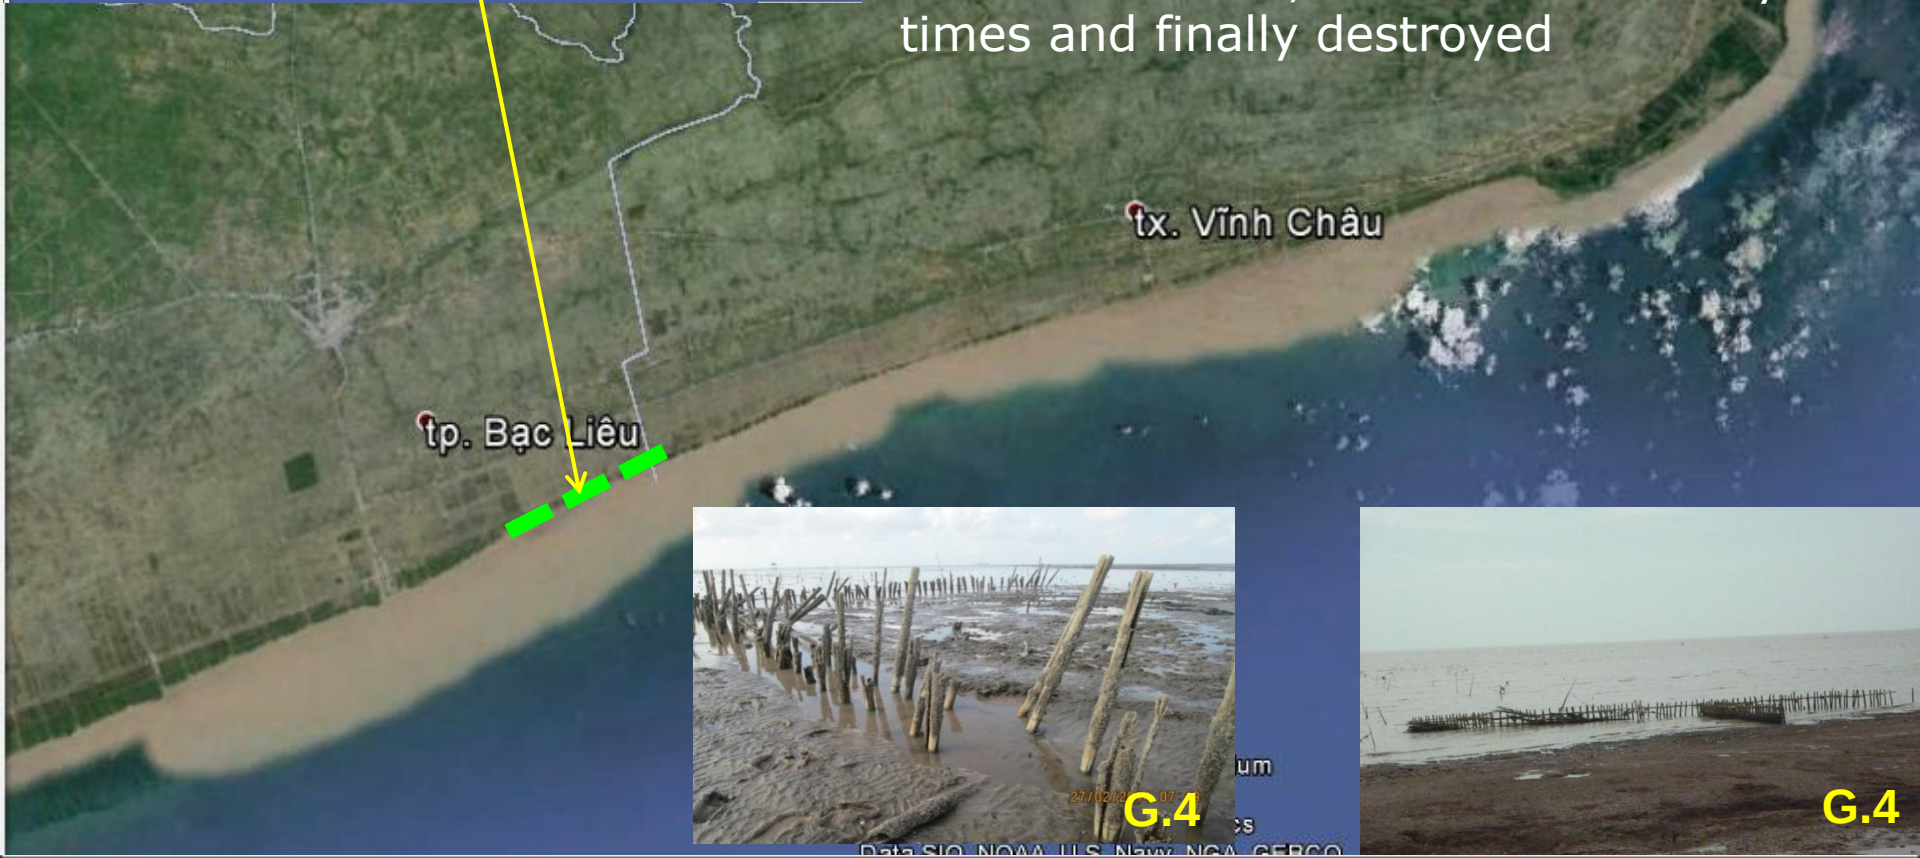
G.4

## 4. Bac Lieu– Vinh Trach Dong: Bamboo breakwater fence : L= 2.40 Km

**Observation : Effective deposition, short life (1-2 year?)**

Bamboo fence again applied by WIP (Institute for ecology and work protection) design....construction, not yet trapping enough sediment for afforestation, maintenance many times and finally destroyed

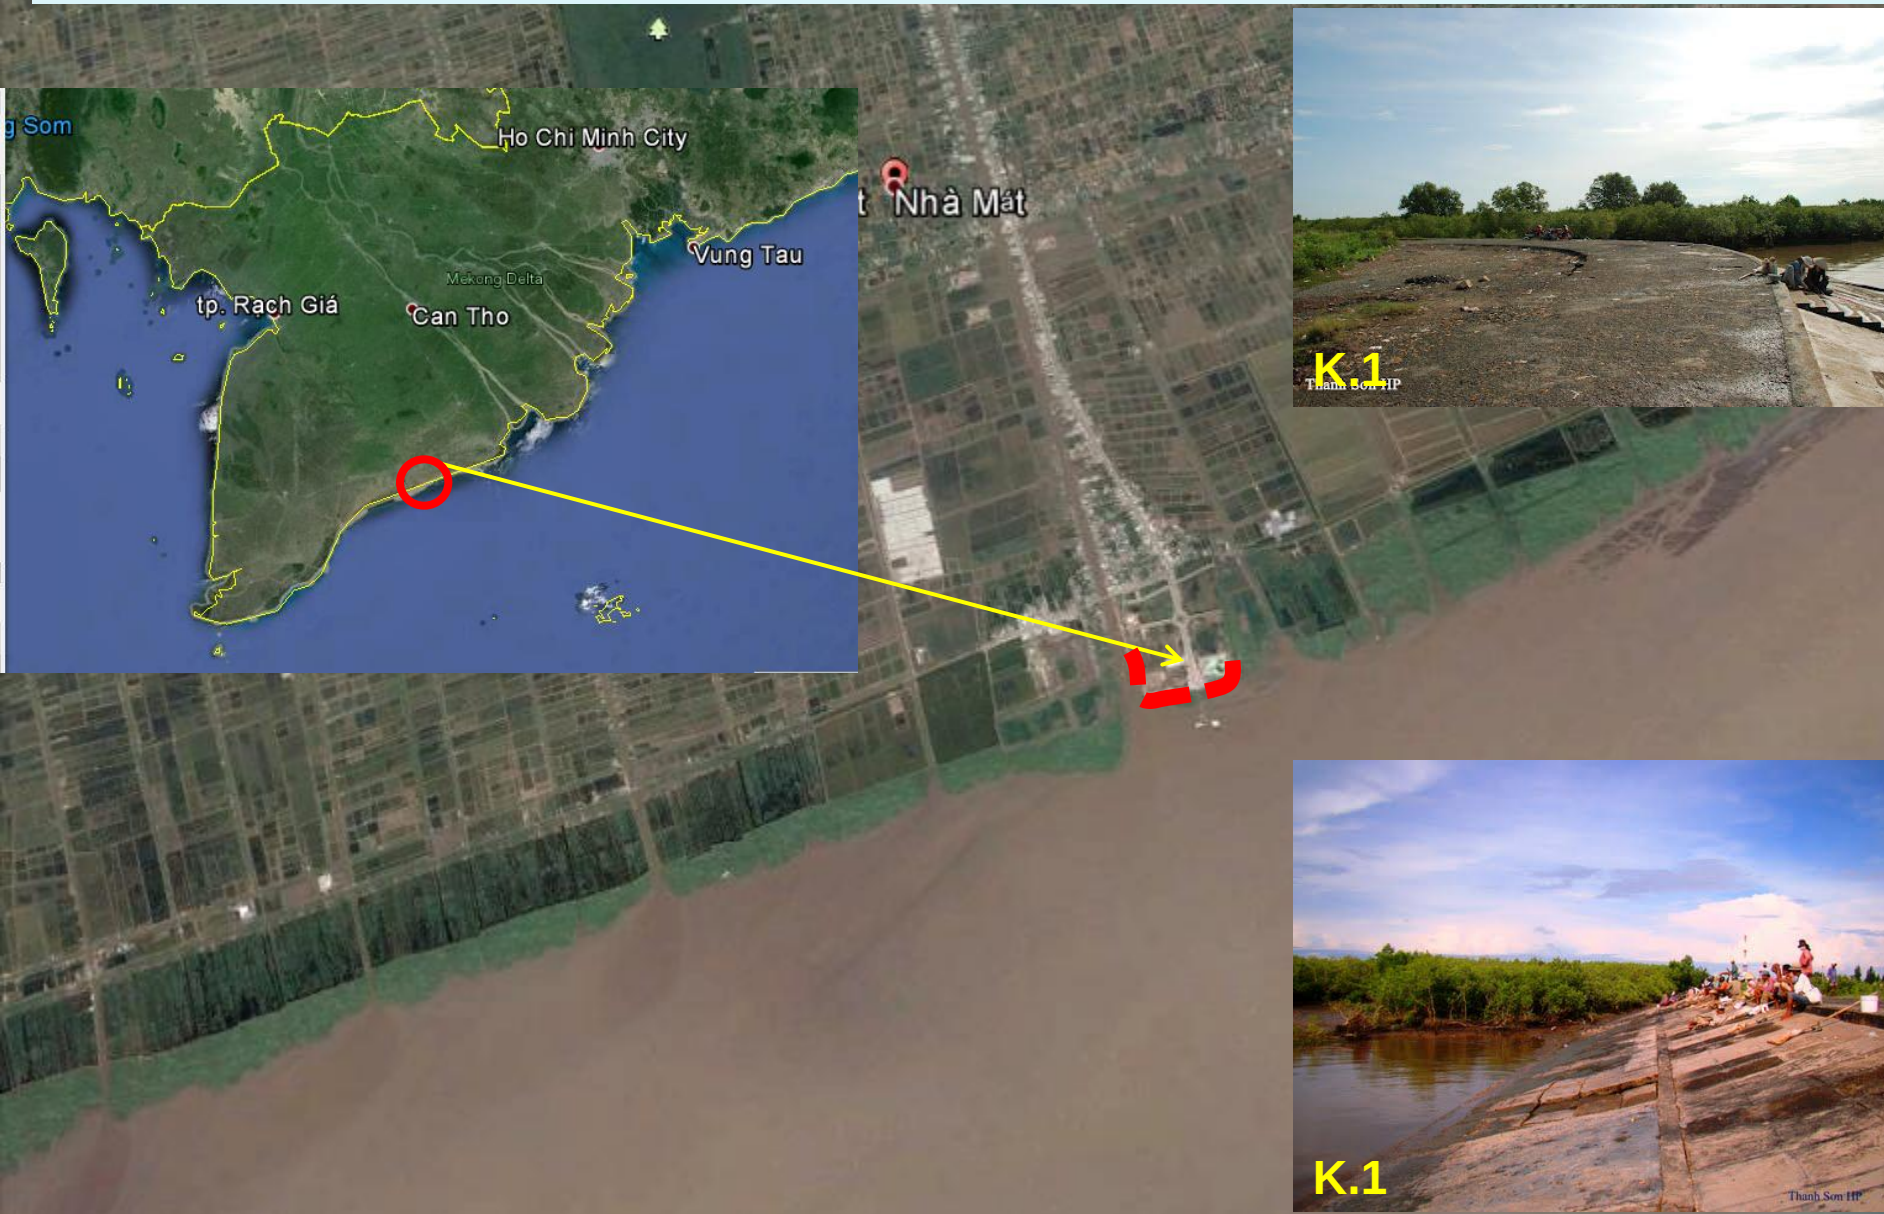
## 4. Bac Lieu– Nha Mat Revetment: $L = 1.14$ Km

**Observation: Protected from erosion of shore, need mangrove belt**

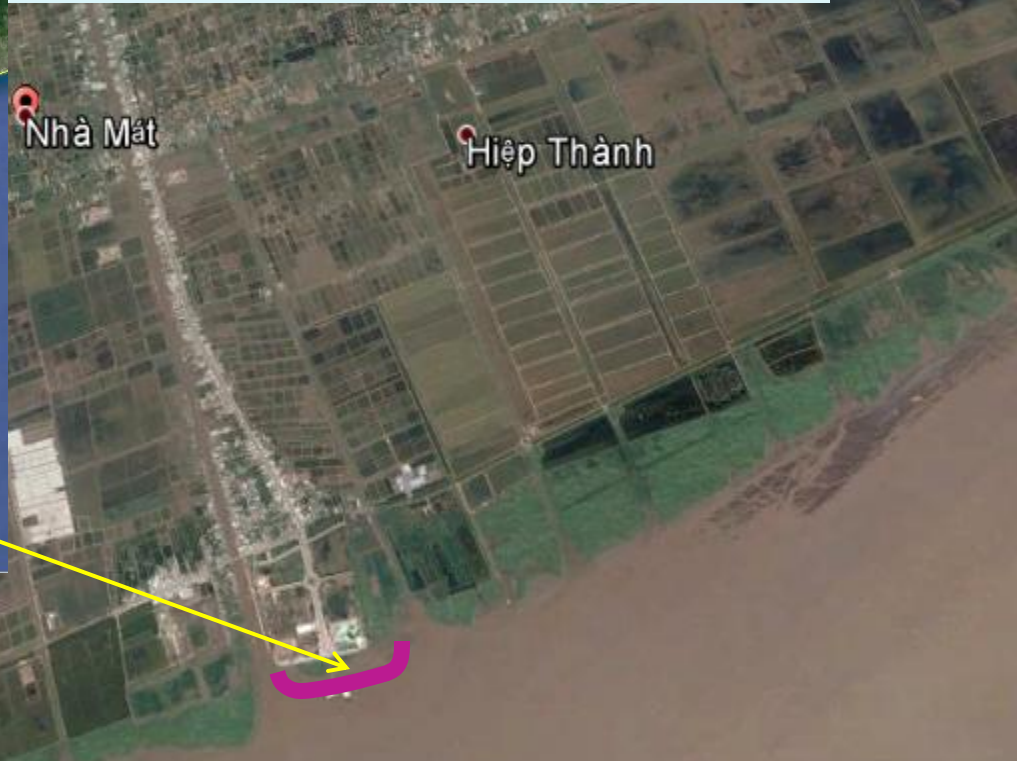
G.3

## 4. Bac Lieu- Nha Mat: Geotube wave breaker $L = 1.056 \text{ Km}$

**Observation : Low deposition – short life (1 year?), needed improve**

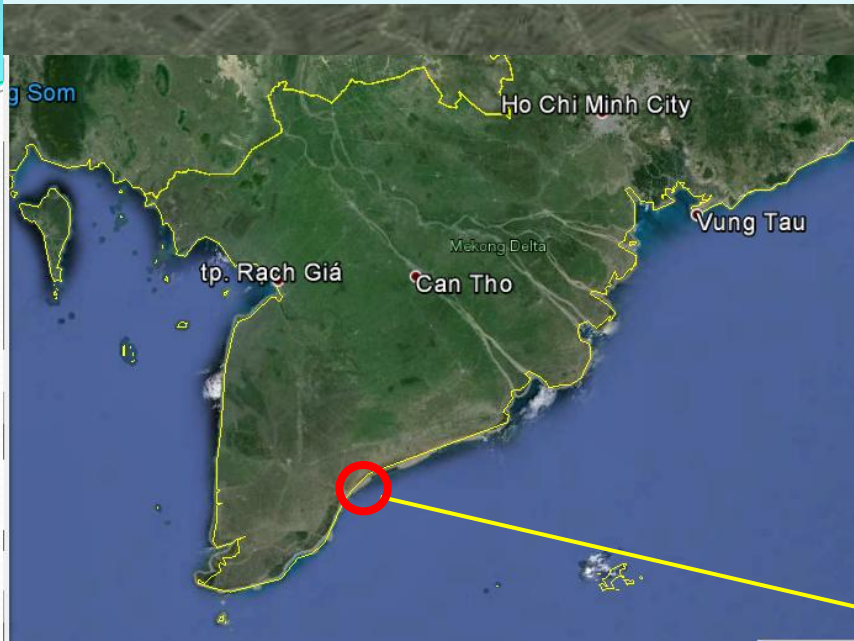
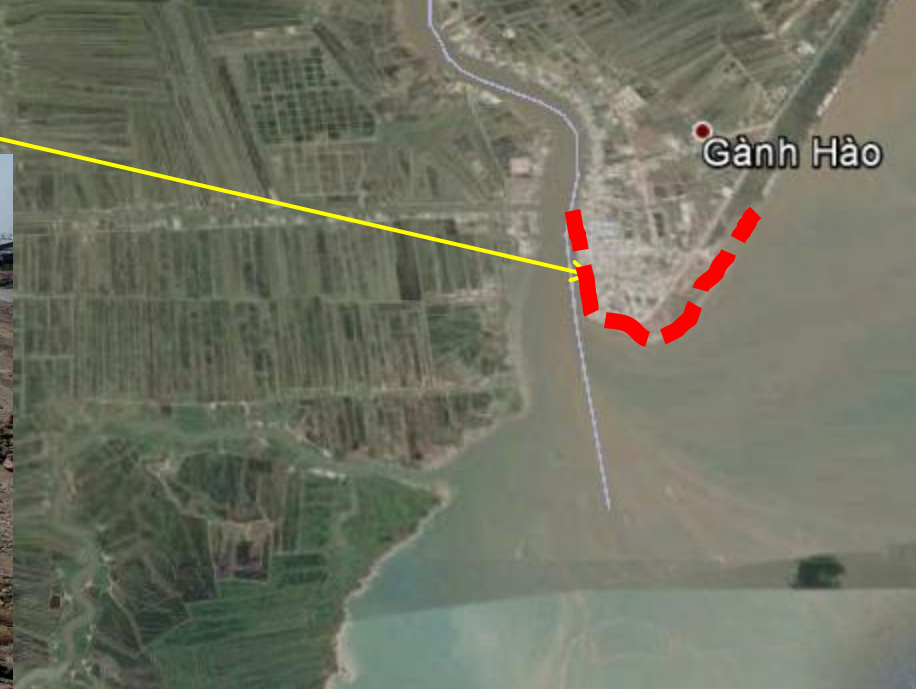
## 4. Bac Lieu- Ganh Hao Revetment: L= 3.432 Km

**Observation: Protected from bank erosion, but long term?**

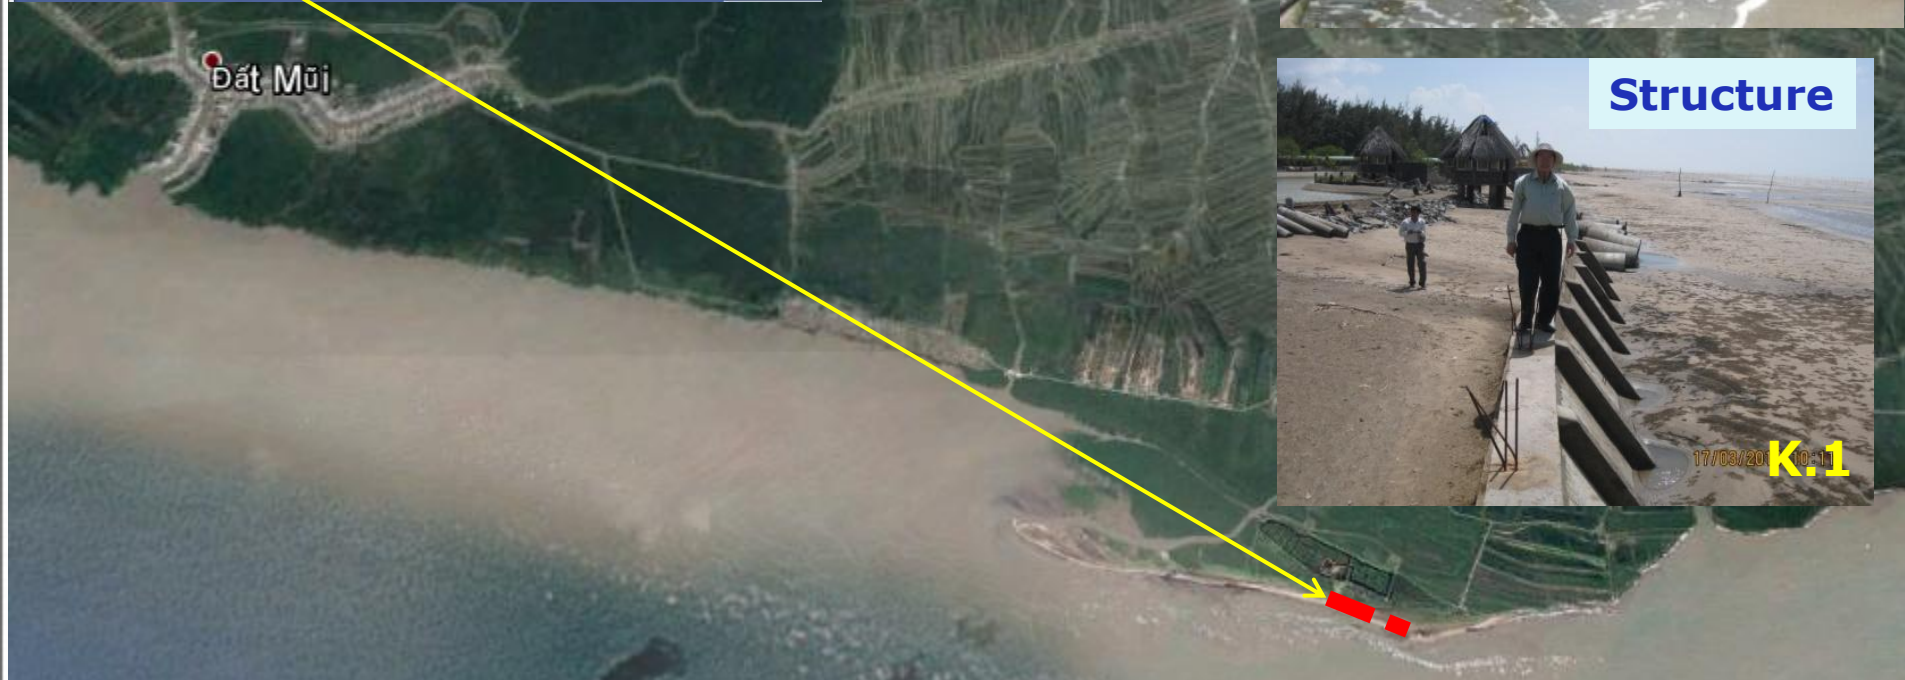
## 5. Ca Mau- Khai Long Revetment- $L=0.35\text{Km}$

**Observation: Protected from bank erosion, but long term?**

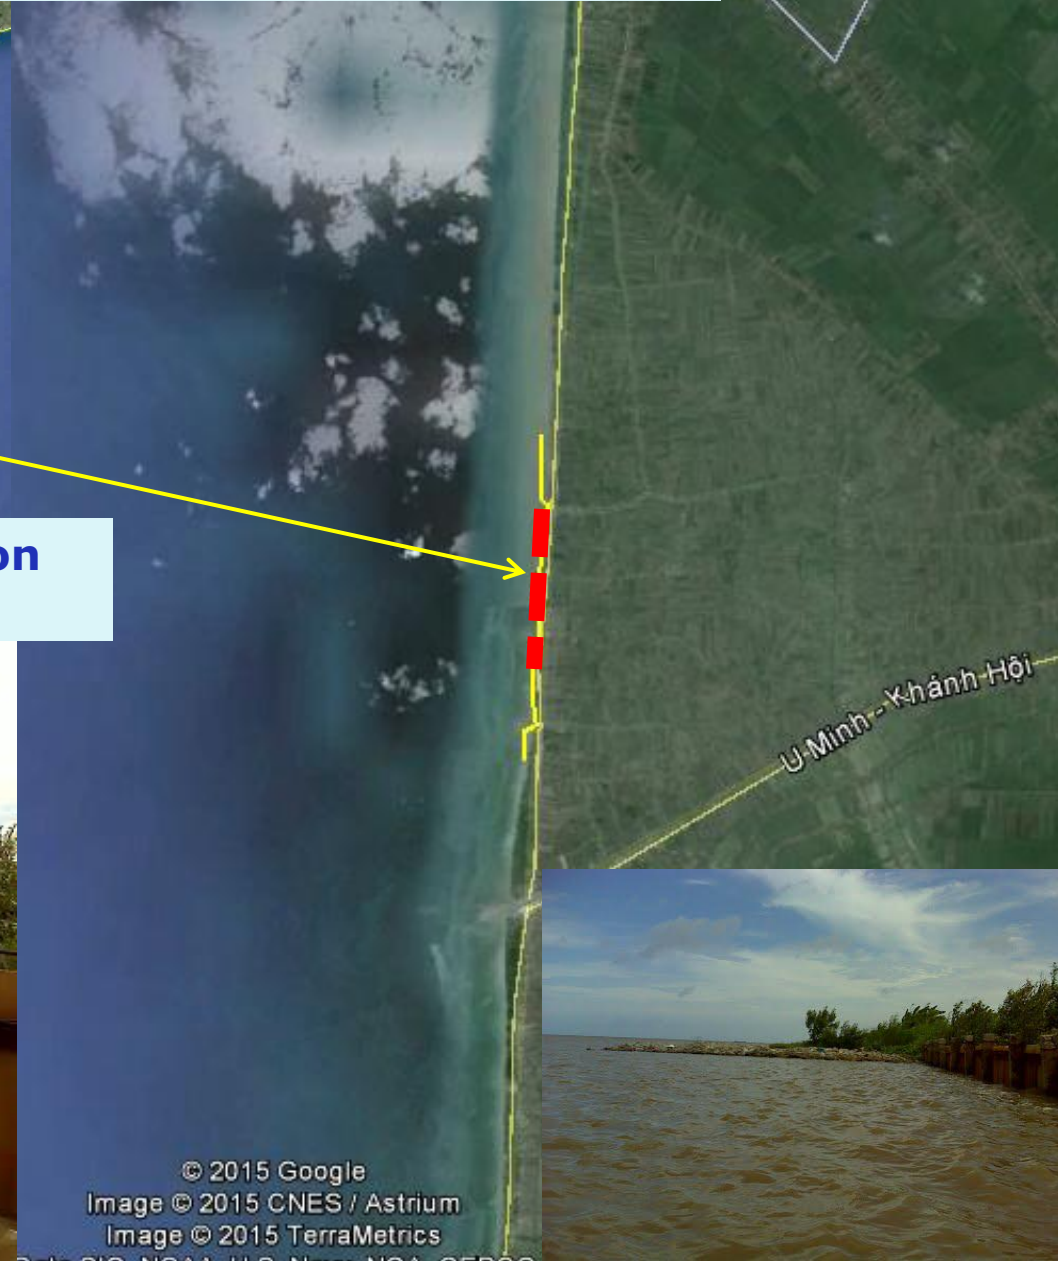
## 5. Ca Mau- Khánh Hội- Concrete and plastic sheet pile. : L= 1.186 Km

**Observation: Protected from erosion ?, long term?**

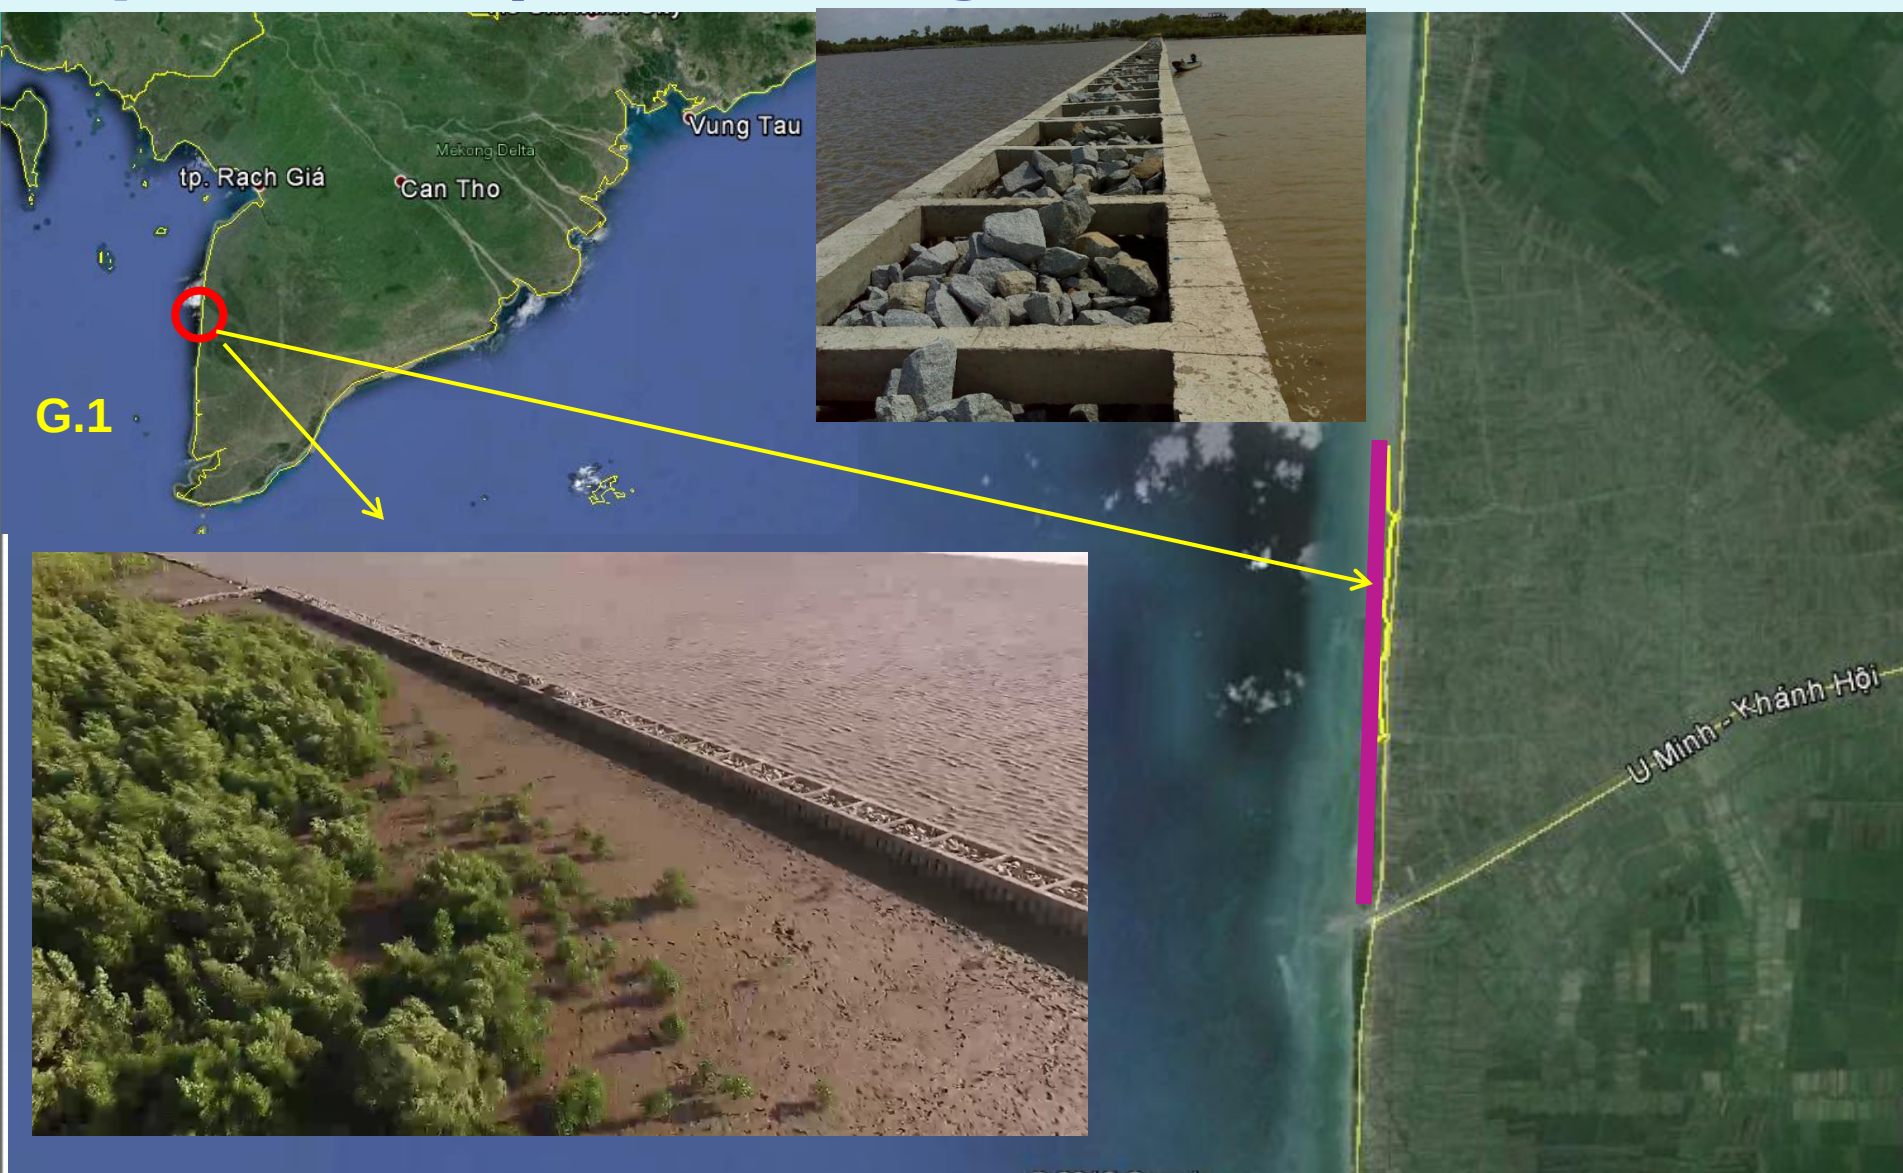
## 5. Ca Mau– Breakwater: Khánh Tiến. Khánh Bình Tây. Khánh Hội. bắc Hương Mai : $L = 10$ Km

**Observation : Effective deposition –toe erosion?..., costly!**

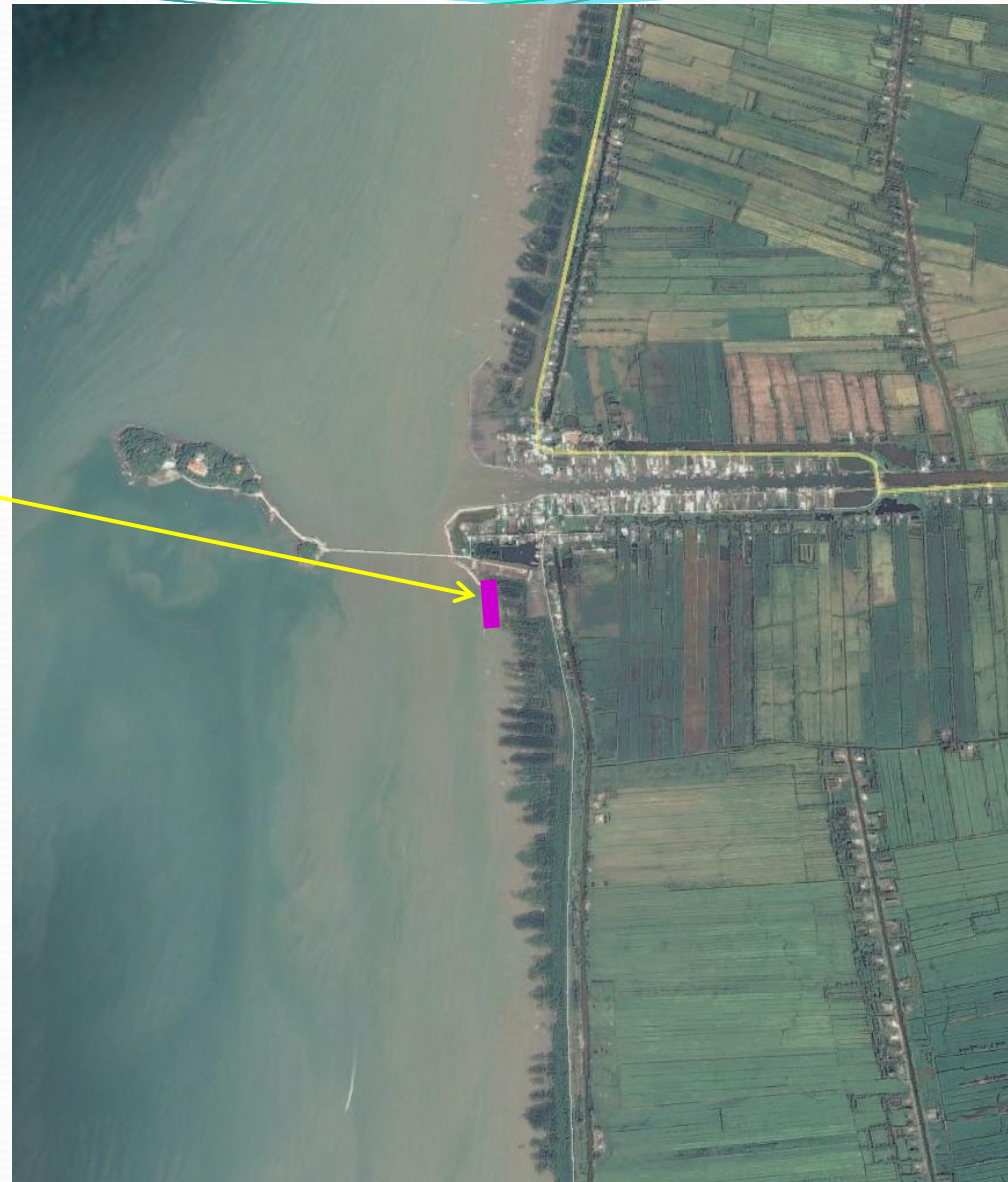
## 5. Ca Mau– Breakwater: Hon Da Bac : L= 160 m

**Observation : Effective deposition?, costly?**

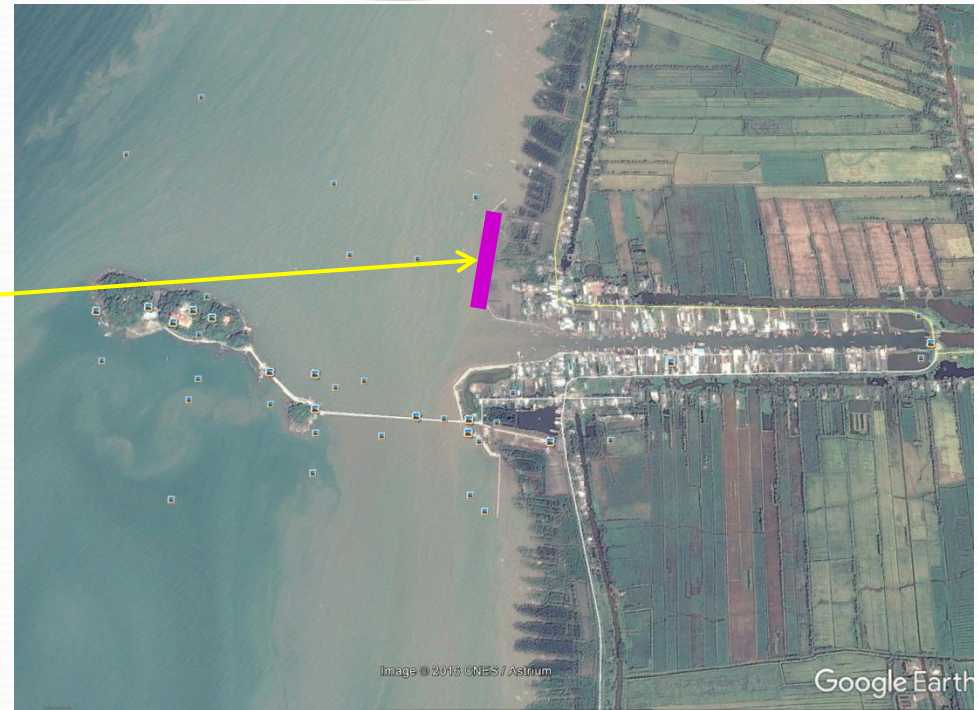
## 5. Ca Mau– Tran Van Thoi (near Hon Da Bac : L= 2,300 km)

Bamboo fence at Tran Van Thoi District, length of 2.3km, 18 billions VNĐ (340 USD/m), WIP design....construction December 2015, not yet trapping enough sediment for afforestation, maintenance many times

**Observation : Effective deposition?, long term?**
