**REPORT ON**

**EXISTING SHORELINE, SEA DYKE AND  
SHORE PROTECTION WORKS IN VIETNAM  
LOWER MEKONG DELTA COASTAL ZONE  
AND  
ORIENTED SOLUTIONS FOR STABILITY**

**2/2017**

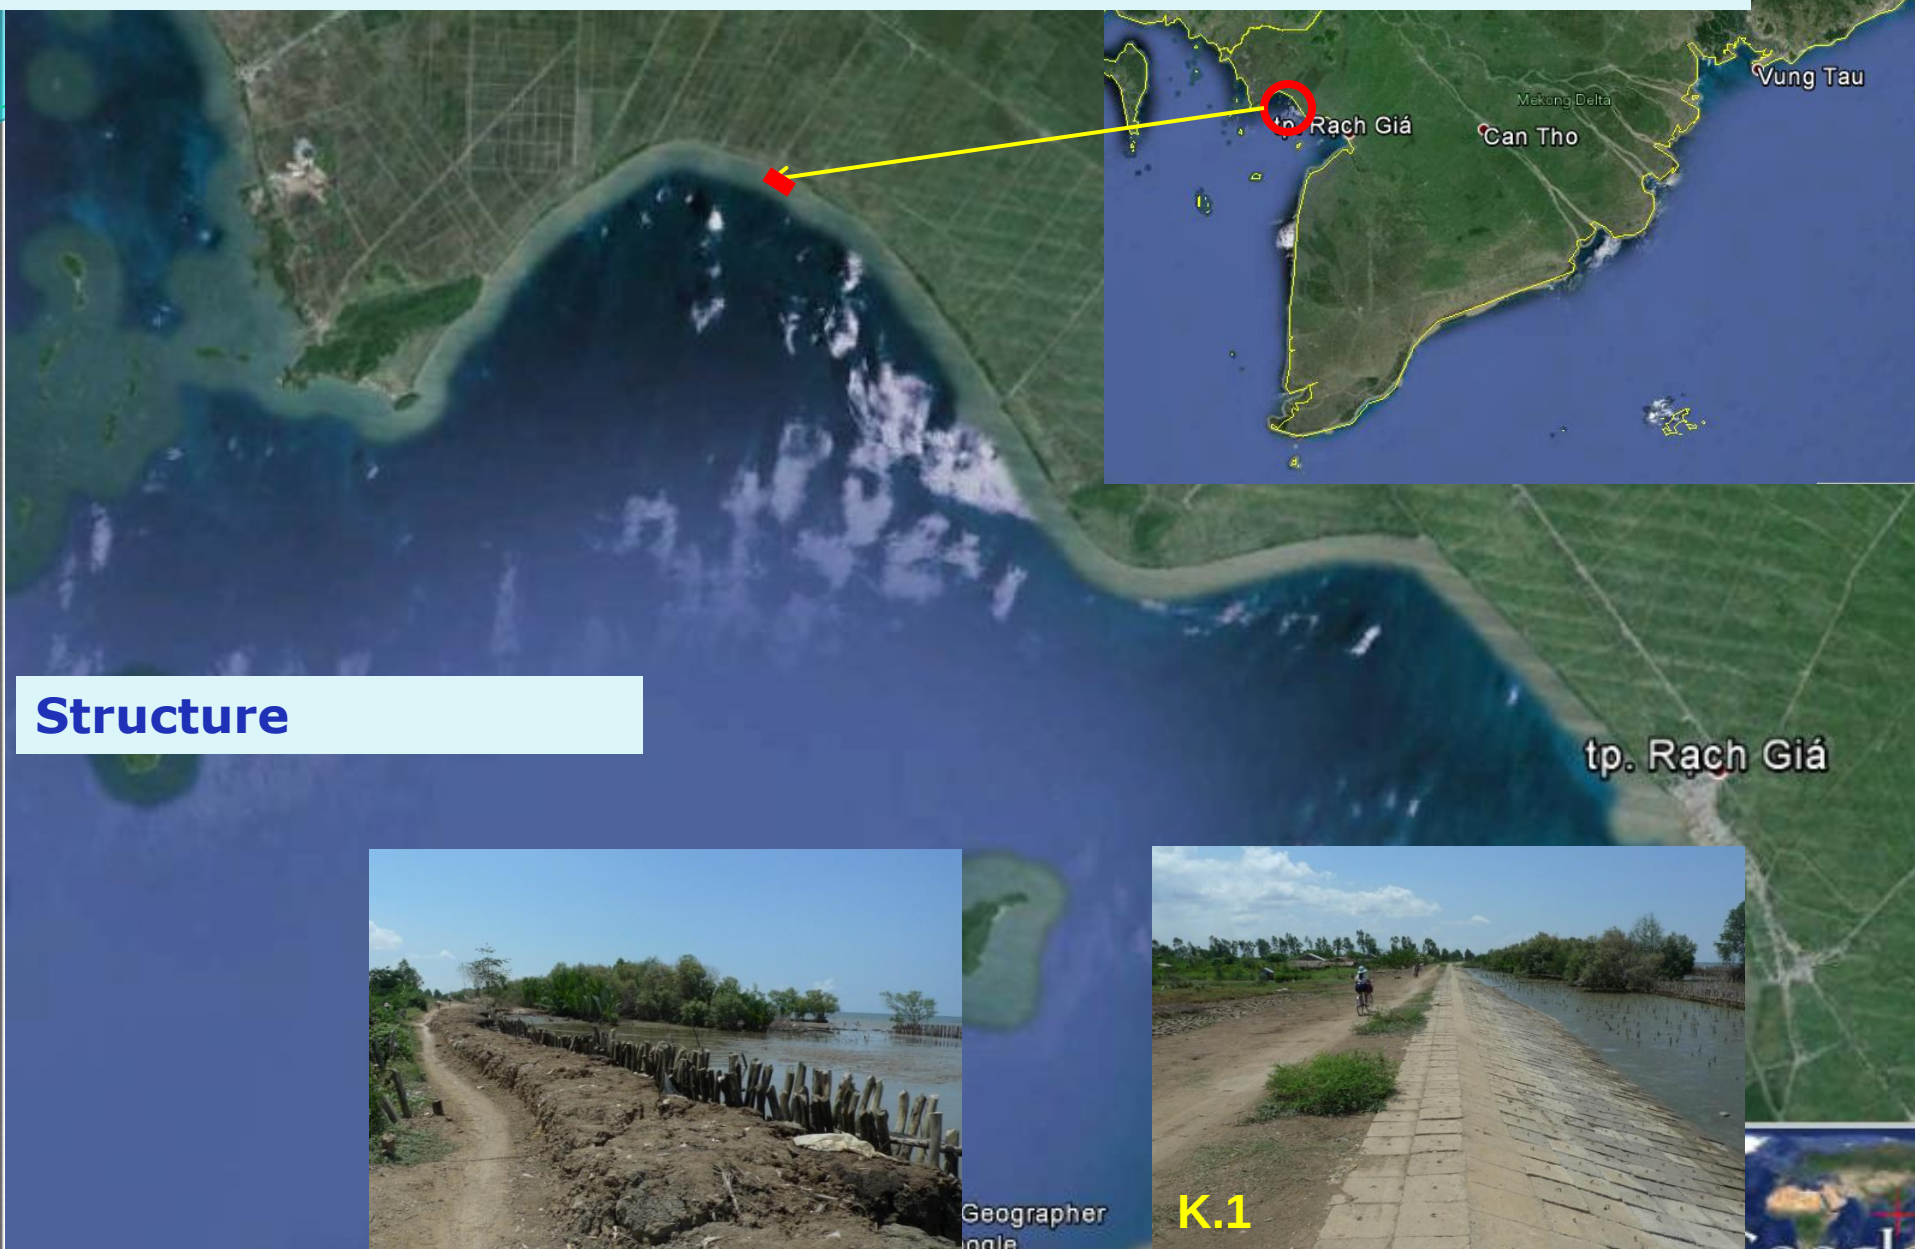
## 6. Kien Giang – Vam Ray Revetment: L= 0.6Km

**Observation : protected from erosion– (mangrove belt exist)**

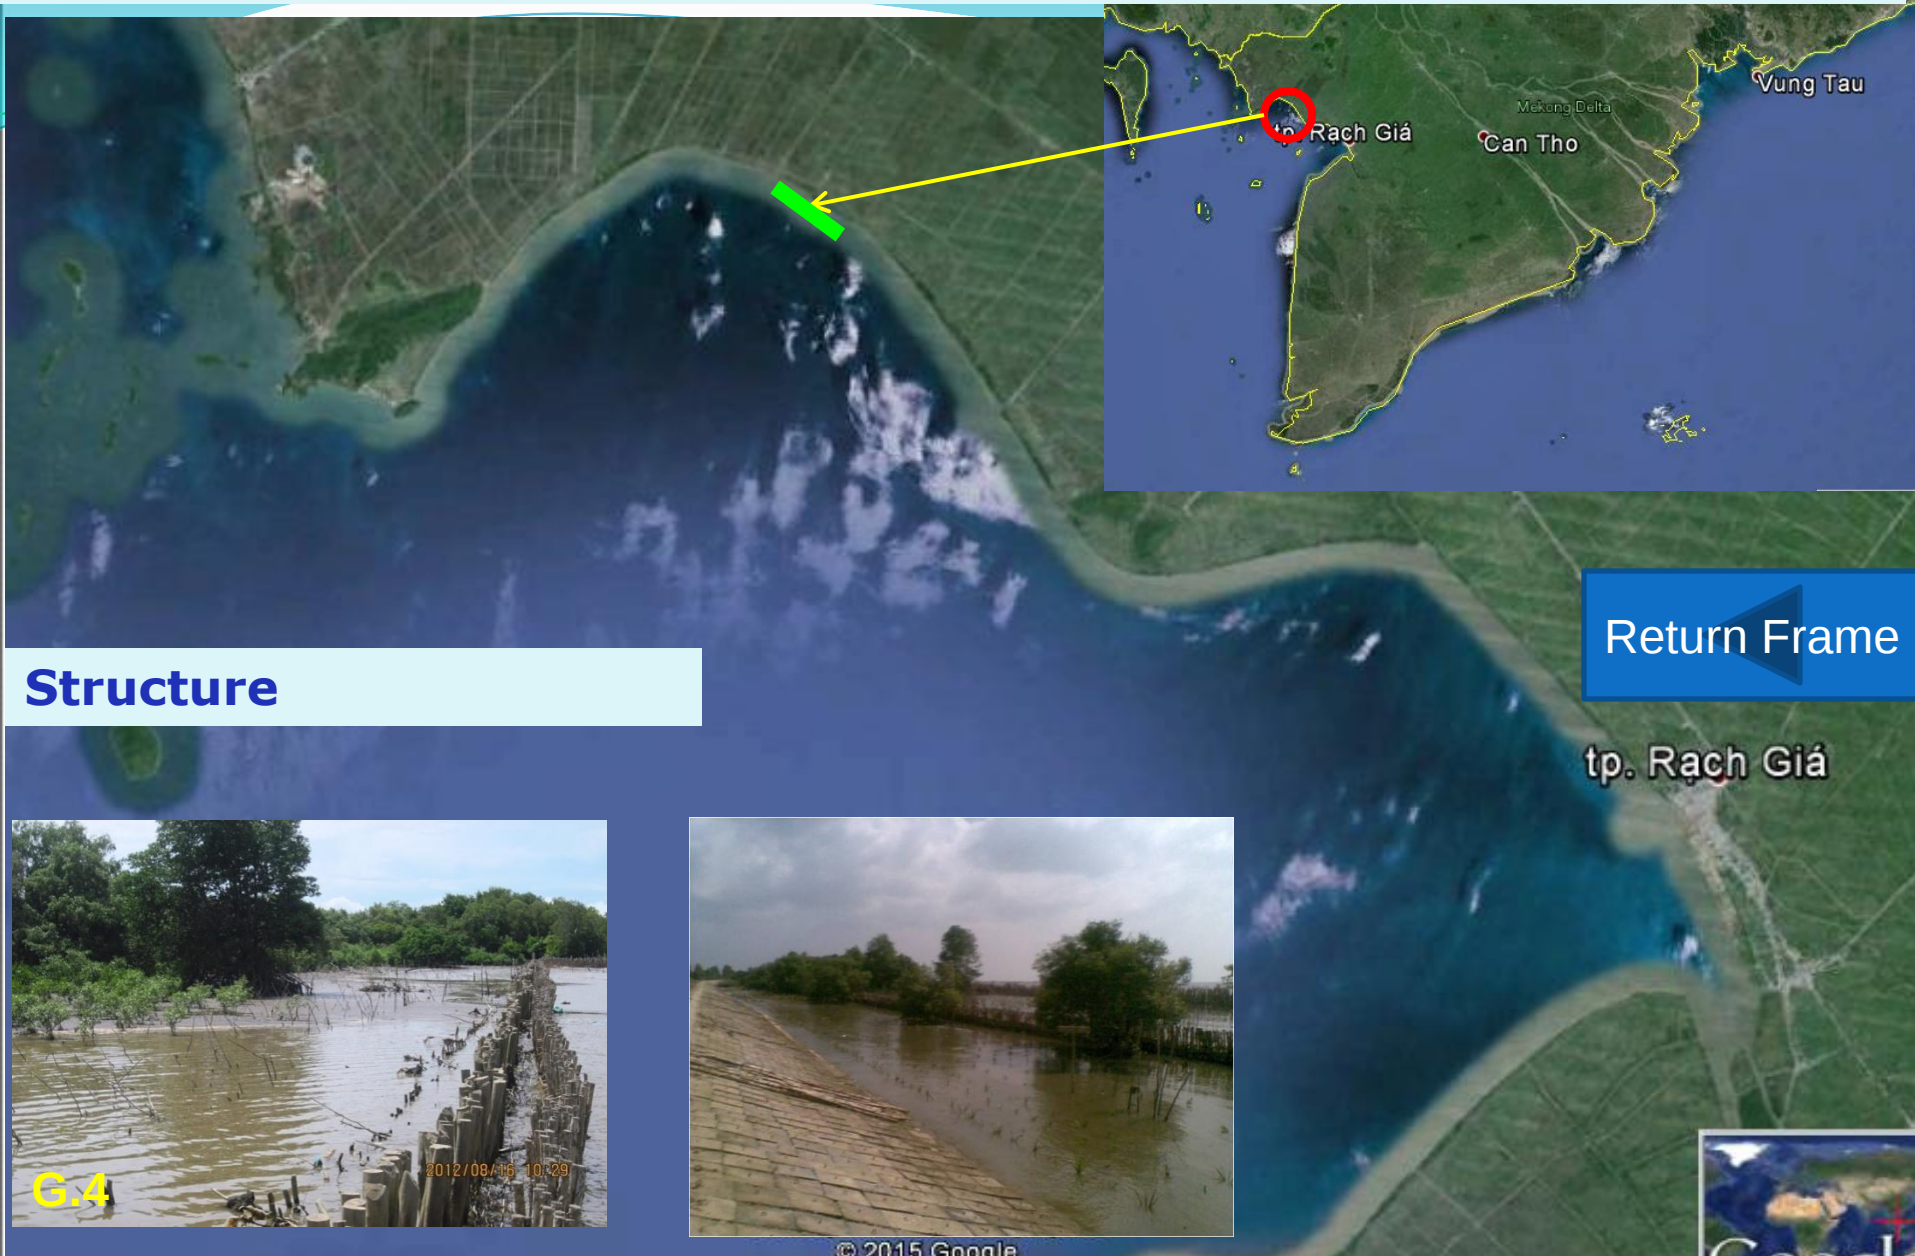
G.4

## 6. Kieng Giang- Vam Ray: Maleuluca fence : L= 3.9 Km

Observation : Effective deposition – low wave, short life (1 year?)

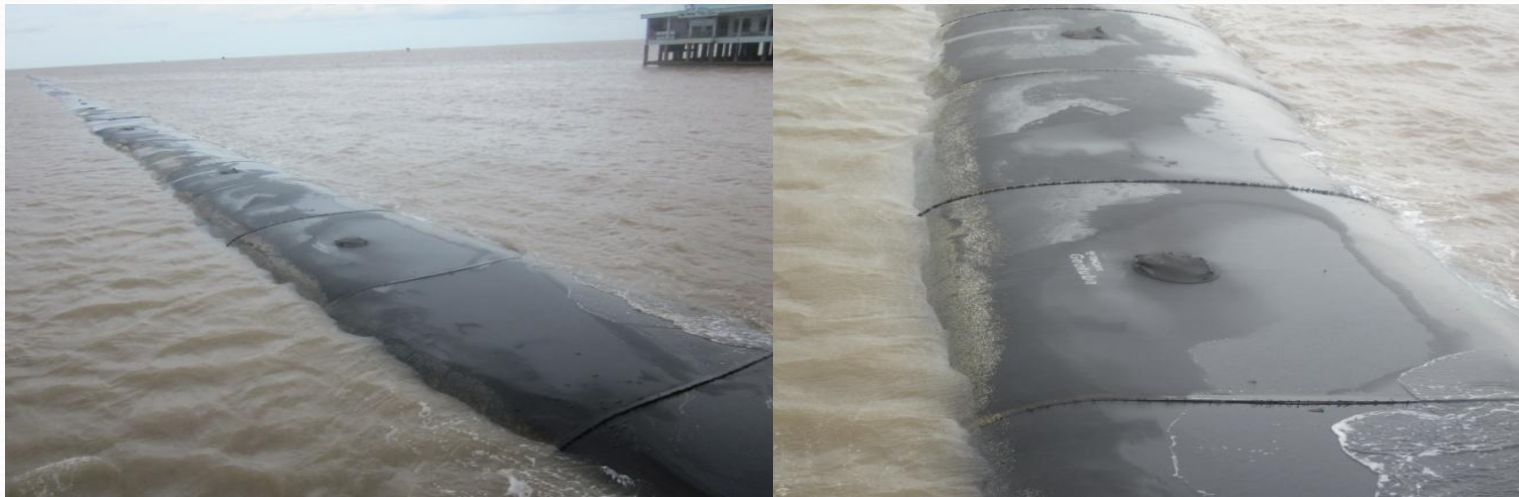
- có thể phá sóng bảo vệ bờ phía trong.
- khó gây bồi tạo bãi để khôi phục rừng phòng hộ
- cao trình của các túi địa **cũng không đạt được chiều cao thiết kế** (lún, bơm cát);
- Theo Huesker Synthetic GmbH Germany giá thành cho 1 m dài vào khoảng 300 USD;

*Bảo vệ bãi biển bằng túi Geotubes tại tỉnh Bạc Liêu*

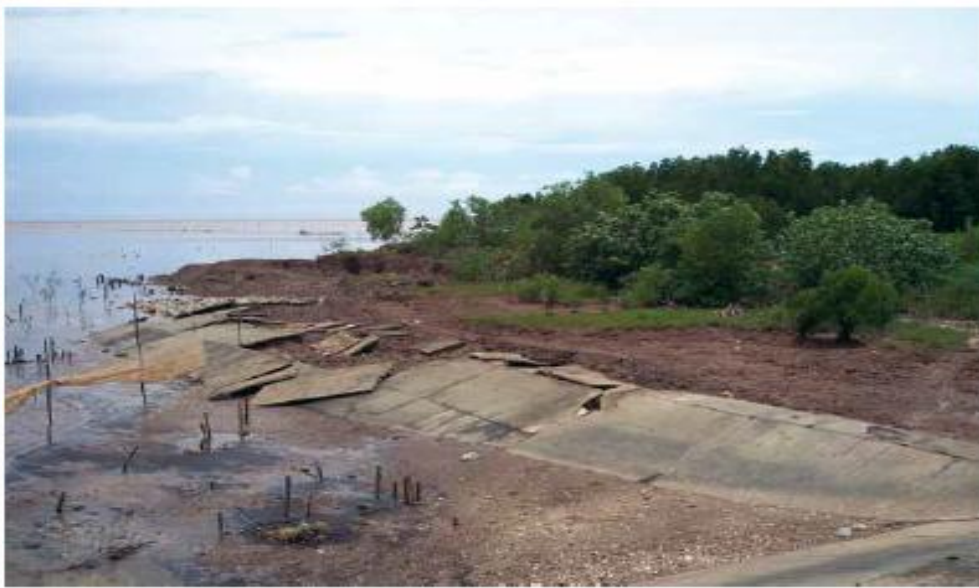
*Kè bị hư hại*

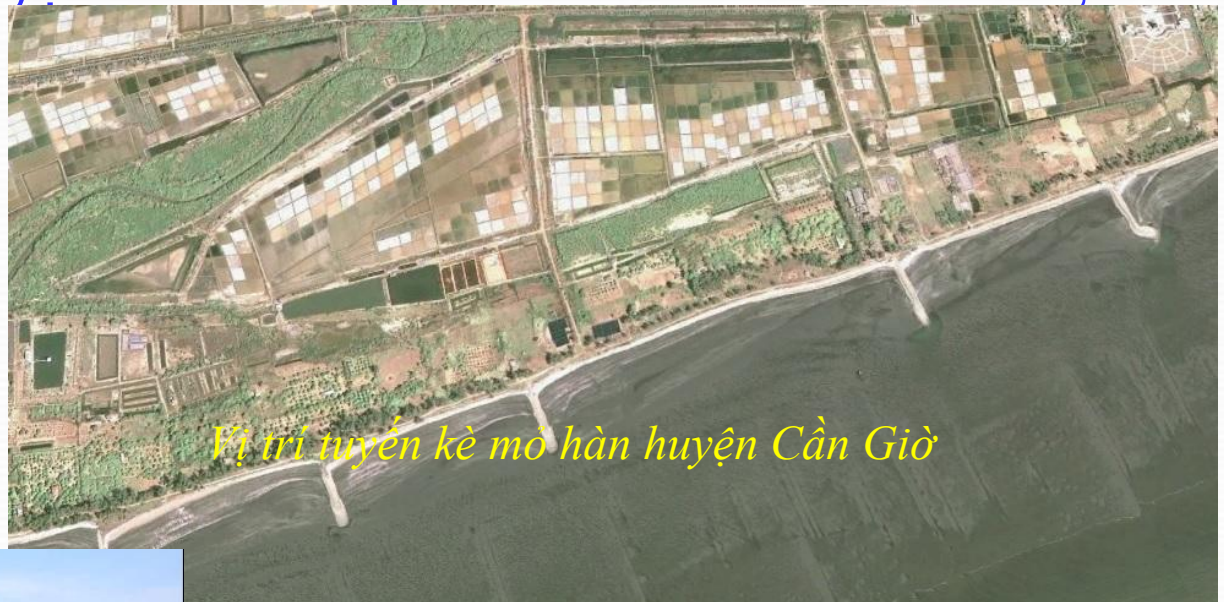
*Nhìn chung toàn tuyến kè hiện tương đối ổn định. nhiều vị trí kè được bồi lắng. tuy vậy cũng có một vài đoạn đang bị sạt lở*

*Sạt lở bờ kè và các mở hàn gần cửa sông  
Sòai Rạp huyện Cần Giờ*

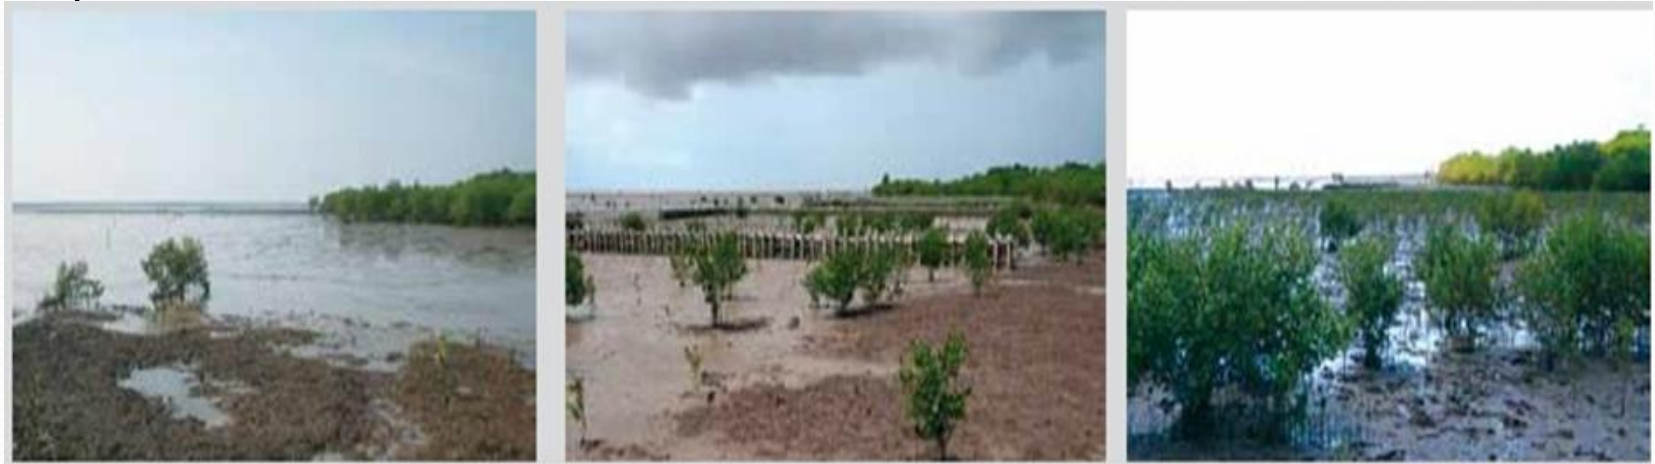
*Kết quả thay đổi tại bờ biển Bạc Liêu sau khi lắp đặt hàng rào tre (tháng 5, tháng 9 và tháng 12 năm 2012)*

Tuy nhiên hiện nay do các yếu tố tự nhiên về sóng, dòng chảy ven bờ... thì hiện nay các hàng rào bằng tre tại bờ biển Bạc Liêu đã bị phá hoại. bãi bồi và cây ngập mặn bị sóng phá hủy
