**REPORT ON**

**EXISTING SHORELINE, SEA DYKE AND  
SHORE PROTECTION WORKS IN VIETNAM  
LOWER MEKONG DELTA COASTAL ZONE  
AND  
ORIENTED SOLUTIONS FOR STABILITY**

**2/2017**

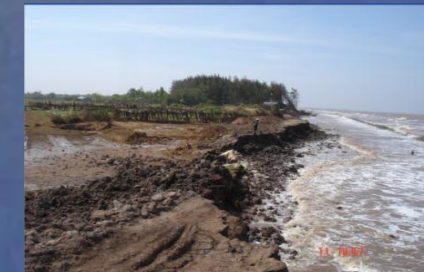
K.1

## 2. Tra Vinh- Hiep Thanh Revetment L= 1.325Km

Old dyke 2006

Dyke in 2007-2008

Revetment built along old dyke line and new dyke set up - 150 m far from old dyke line - 2009

**Observation: Protected from erosion of sand bank**

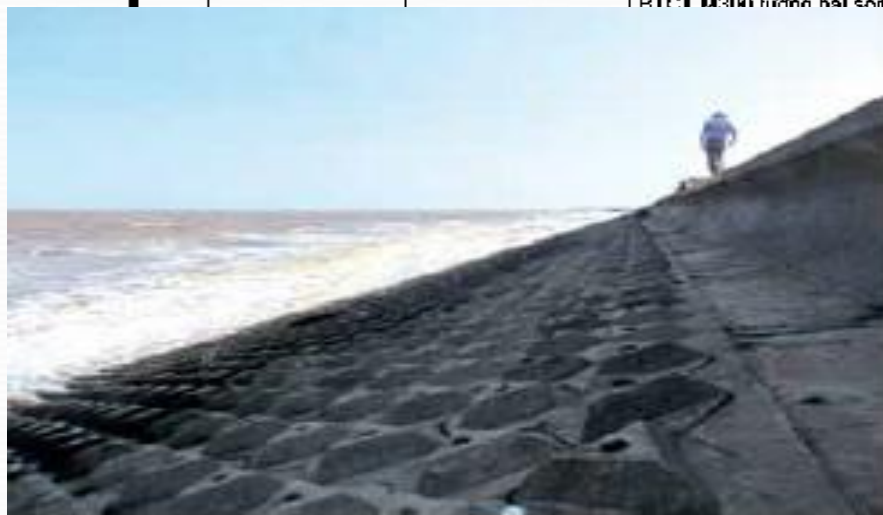
Kè bê tông kết hợp tường chắn thấp  
bờ biển Trà Vinh

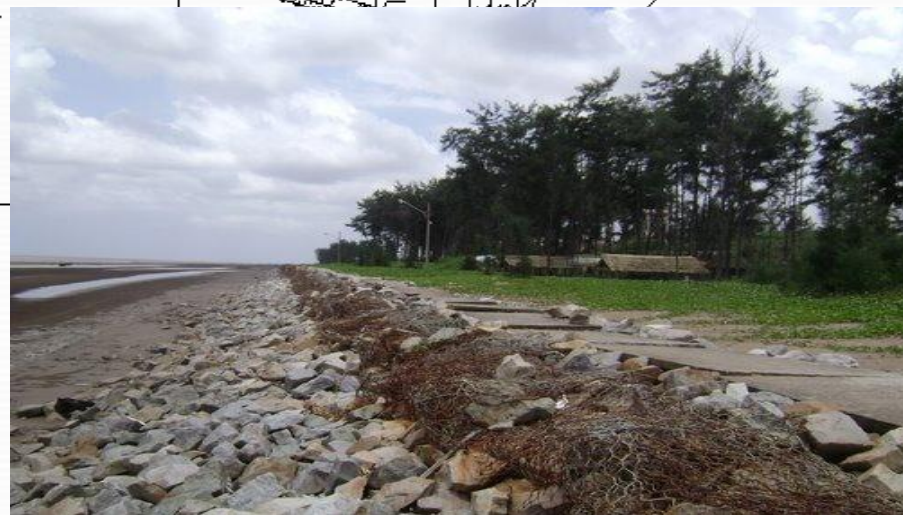
Lưới thép Gabion đoạn kè rọ đá bảo vệ  
khu du lịch Ba Động

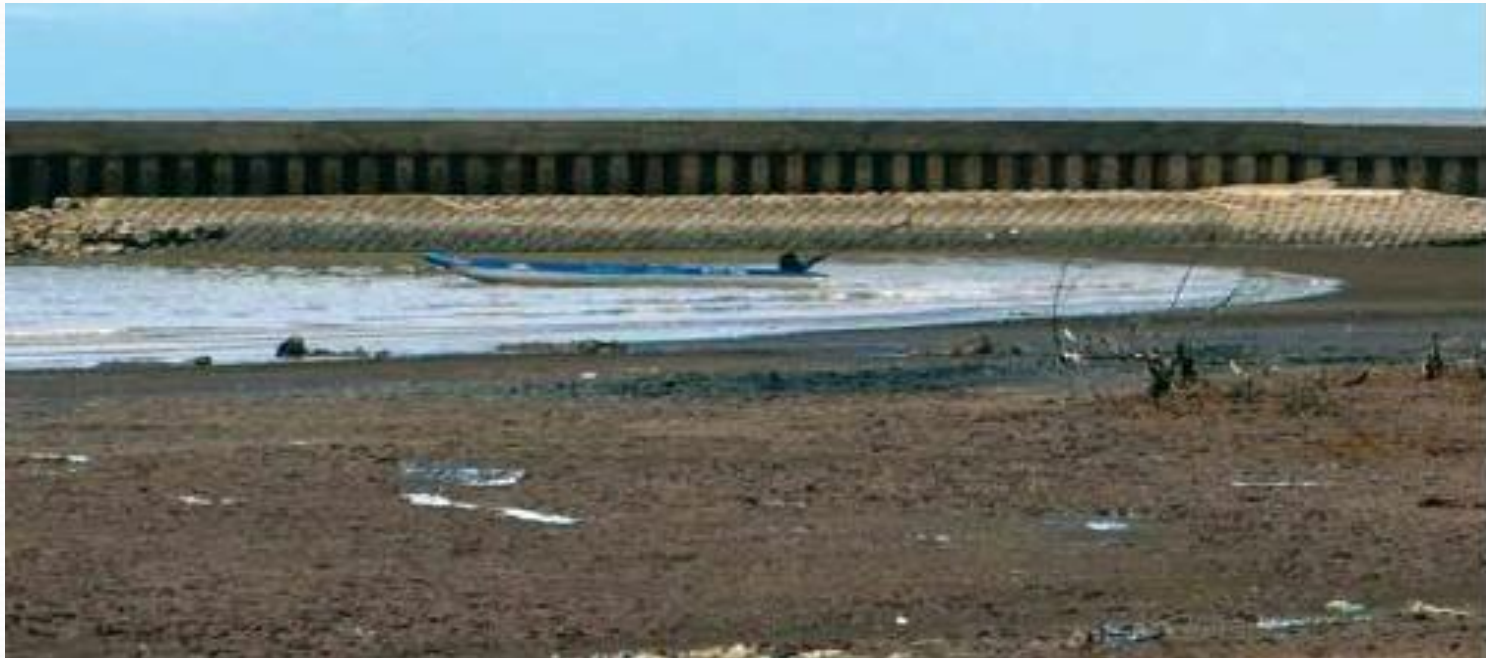
- tường chắn sóng gần như dựng đứng;
- có đặc điểm tiêu cực về phản xạ sóng;
- dẫn đến sự biến mất nhanh của bãi biển;
- giảm sự xói mòn của các trầm tích ở phần nó bảo vệ ;
- tác động tiêu cực đến tổng lượng trầm tích dọc bờ biển liền kề

*Tường chắn sóng Gành Hào – Bạc Liêu*
