**REPORT ON**

**EXISTING SHORELINE, SEA DYKE AND  
SHORE PROTECTION WORKS IN VIETNAM  
LOWER MEKONG DELTA COASTAL ZONE  
AND  
ORIENTED SOLUTIONS FOR STABILITY**

**2/2017**

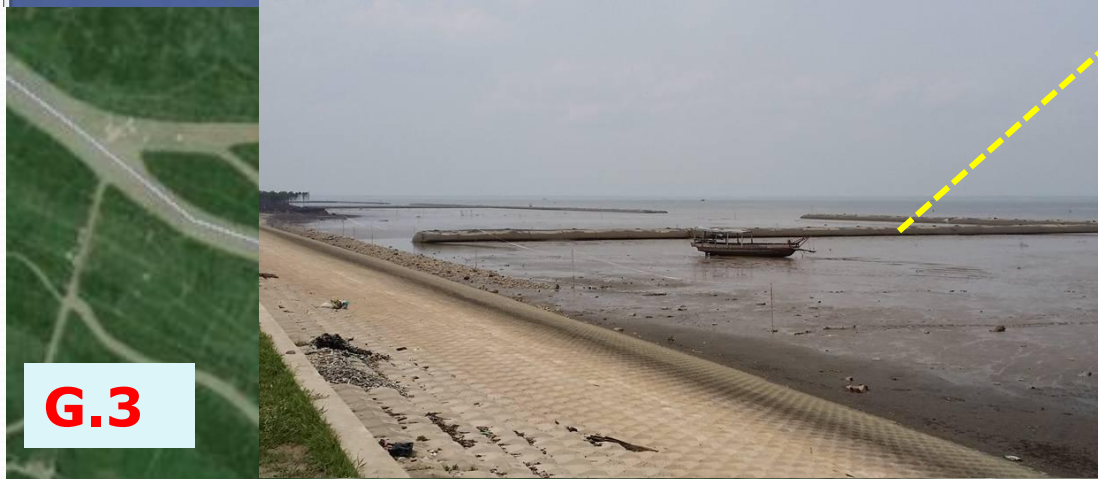
**G.3**

# 1. Tien Giang- GoCong Geotube breakwater (G3); L= 400 ? m

**Observation: it has just been constructed in 2016? It has to be monitoring for few years for evaluation (several NE monsoon seasons)**

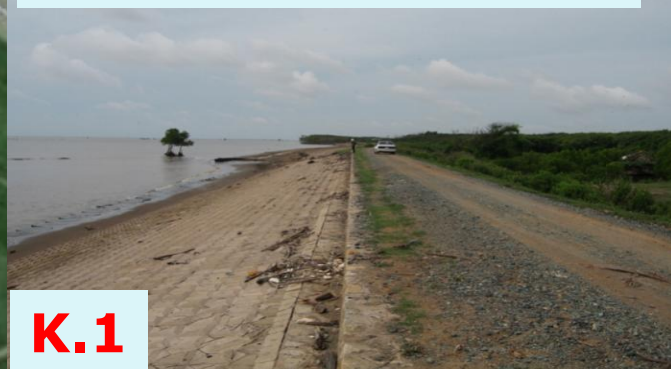
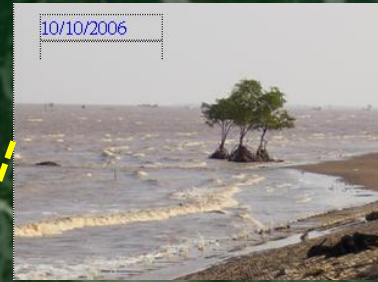
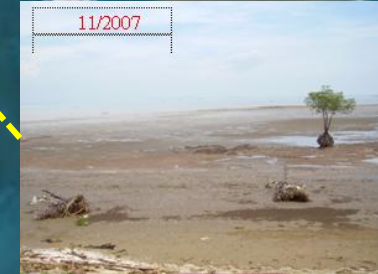
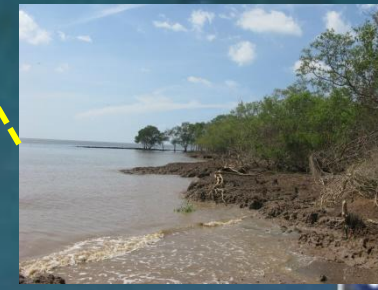
**K.1**

# 1. Tien Giang- GoCong Revetment (GC1.GC2.GC3); L= 5 Km

**Observation: Protected from erosion but no long-term guarantee due to there is no mangroves in the front, needed breakwater and mangrove rehabilitation**

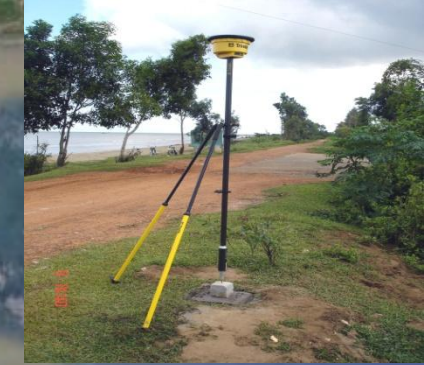
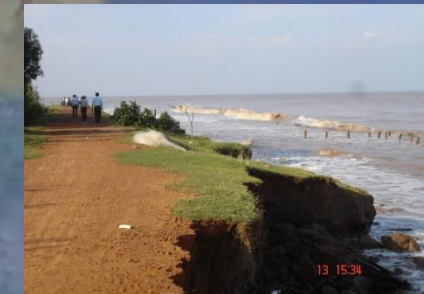
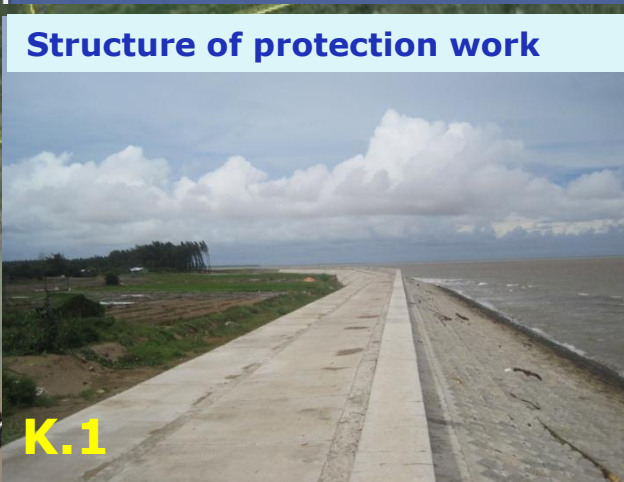
K.1

## 2. Tra Vinh- Hiep Thanh Revetment L= 1.325Km

Old dyke 2006

Dyke in 2007-2008

Revetment built along old dyke line and new dyke set up - 150 m far from old dyke line - 2009

**Observation: Protected from erosion of sand bank**

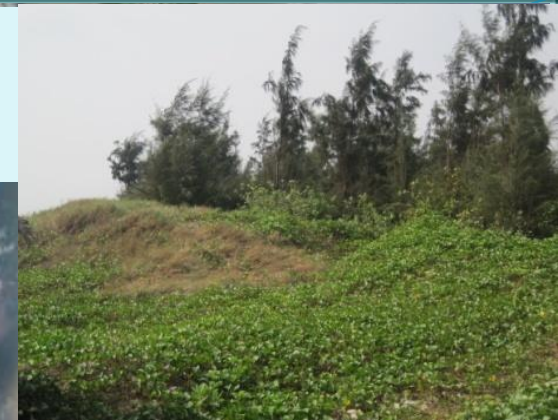
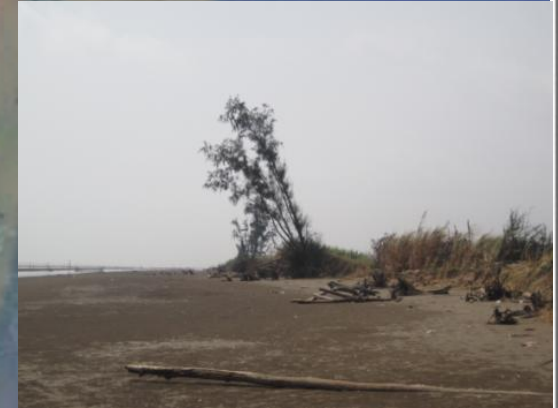
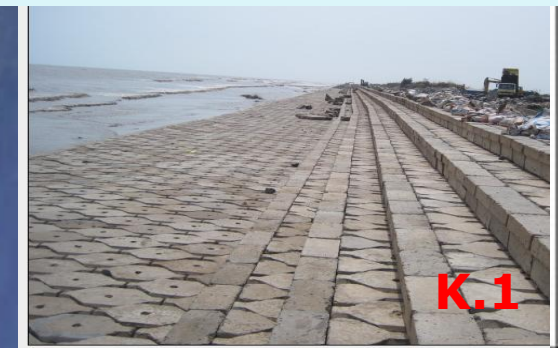
K.1

## 2. Tra Vinh – Con Trung Revetment– L= 750m

2008

2011

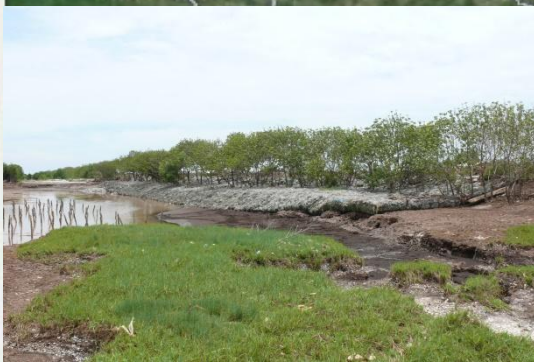
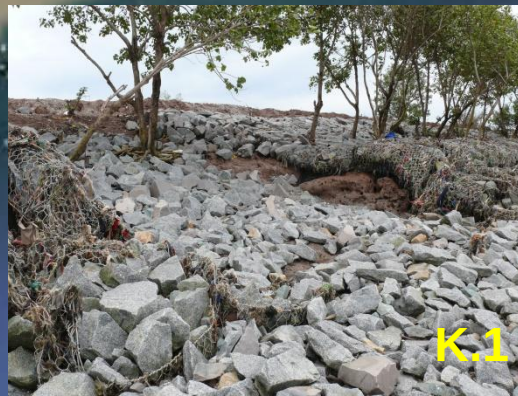
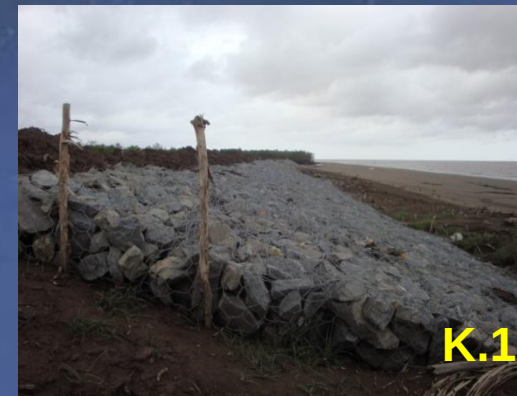
# 3. Soc Trang– Vinh Chau, Vinh Tan Revetments L= 0.58 Km

Observation: Toe erosion

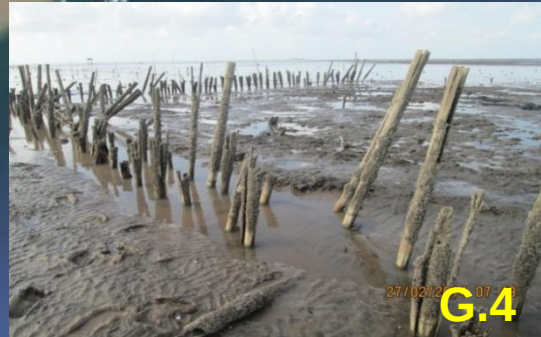
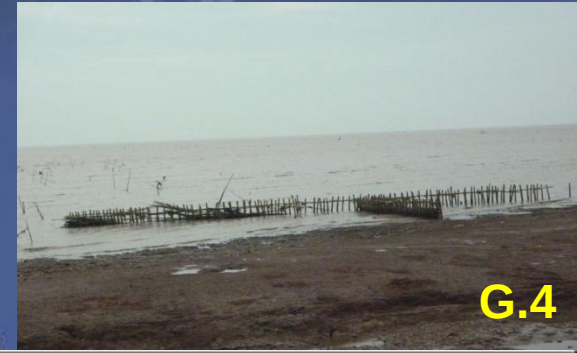
## 4. Bac Lieu– Vinh Trach Dong: Bamboo breakwater fence : L= 2.40 Km

**Observation : Effective deposition, short life (1-2 year?)**

Bamboo fence again applied by WIP (Institute for ecology and work protection) design....construction, not yet trapping enough sediment for afforestation, maintenance many times and finally destroyed

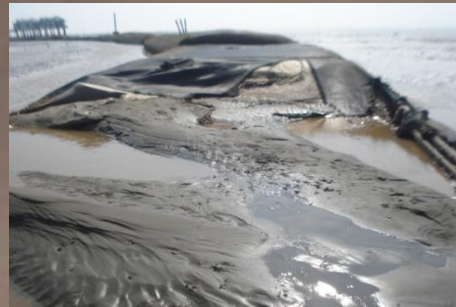
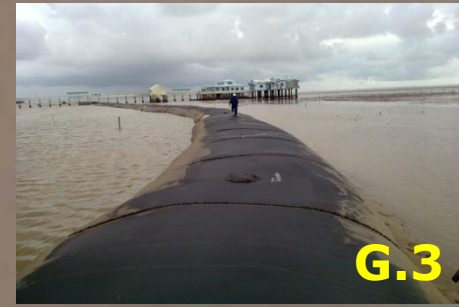
## 4. Bac Lieu- Nha Mat: Geotube wave breaker $L = 1.056 \text{ Km}$

**Observation : Low deposition – short life (1 year?), needed improve**

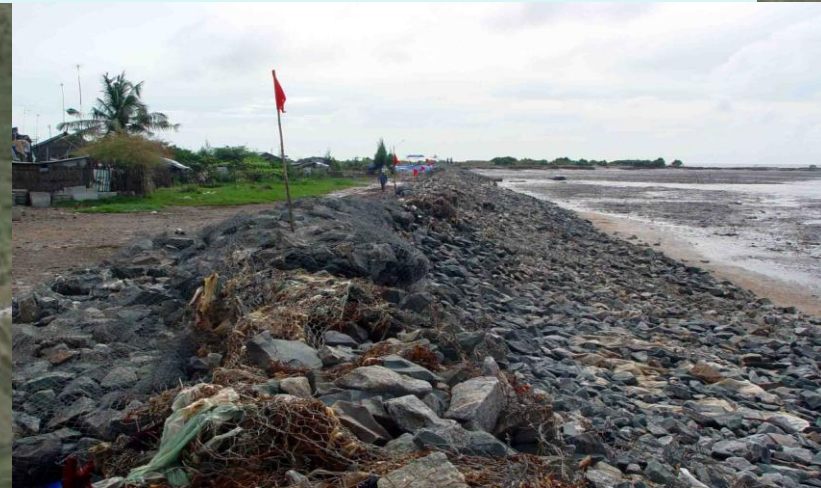
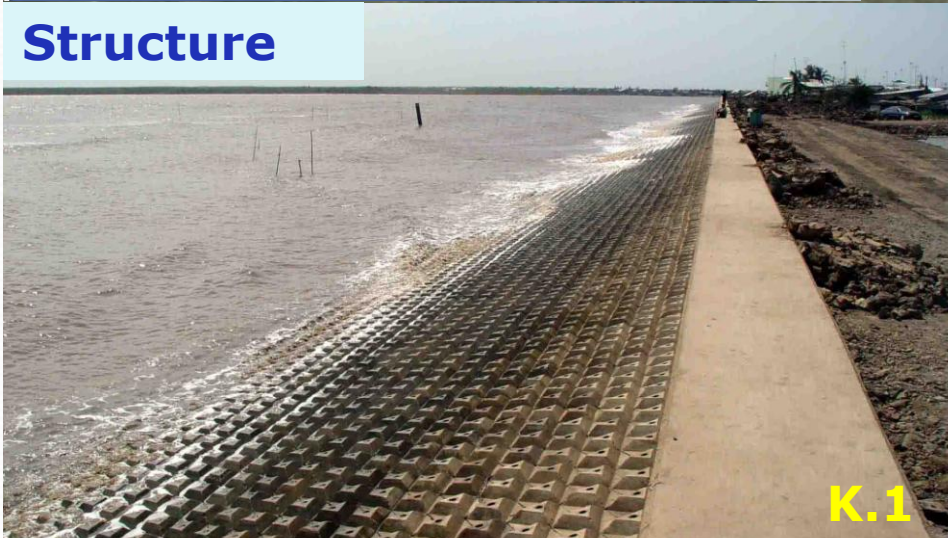
## 4. Bac Lieu- Ganh Hao Revetment: L= 3.432 Km

**Observation: Protected from bank erosion, but long term?**

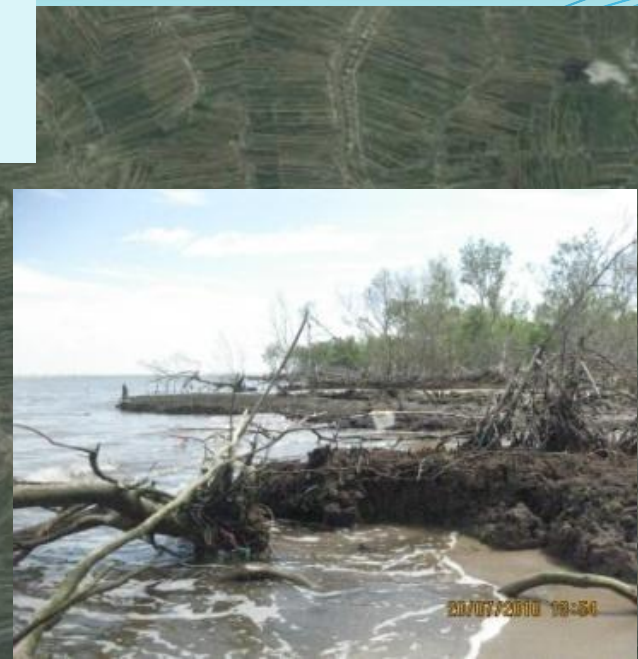
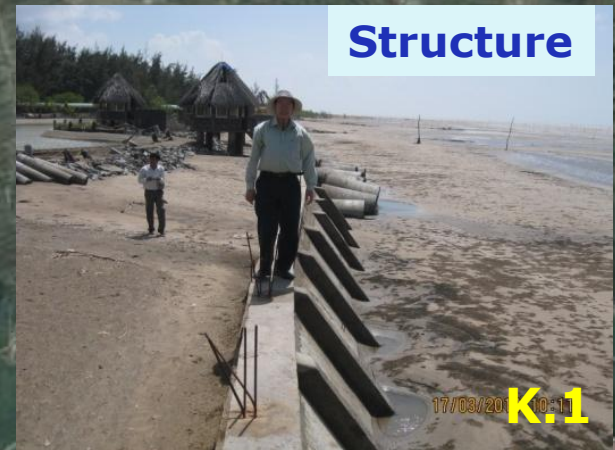
## 5. Ca Mau- Khai Long Revetment- $L=0.35\text{Km}$

**Observation: Protected from bank erosion, but long term?**

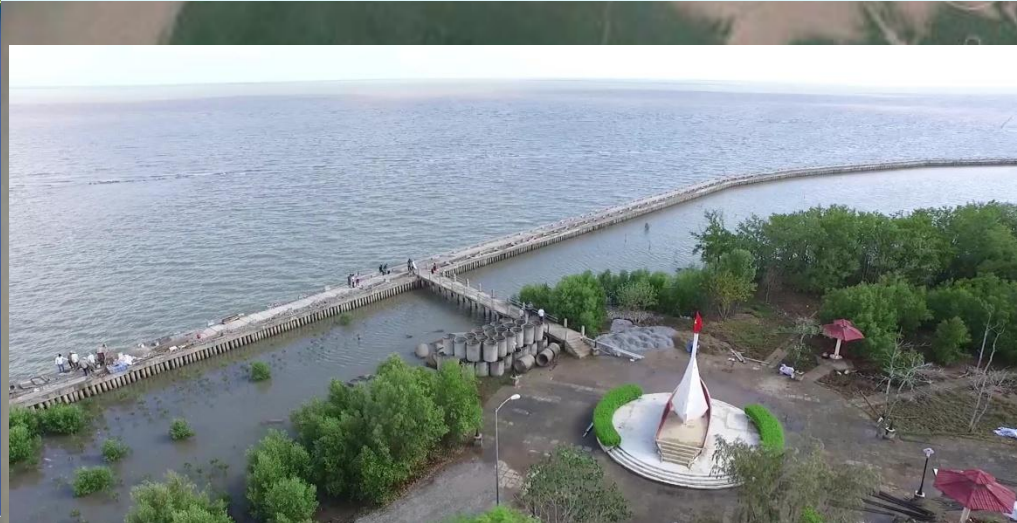
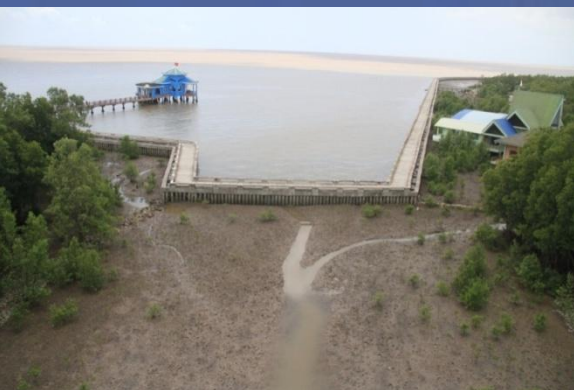
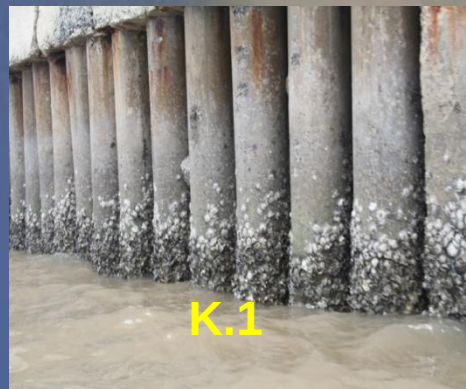
## 5. Ca Mau- Dat Mui Revetment: L= 1.5Km

**Observation: Protected from erosion, but long term?**

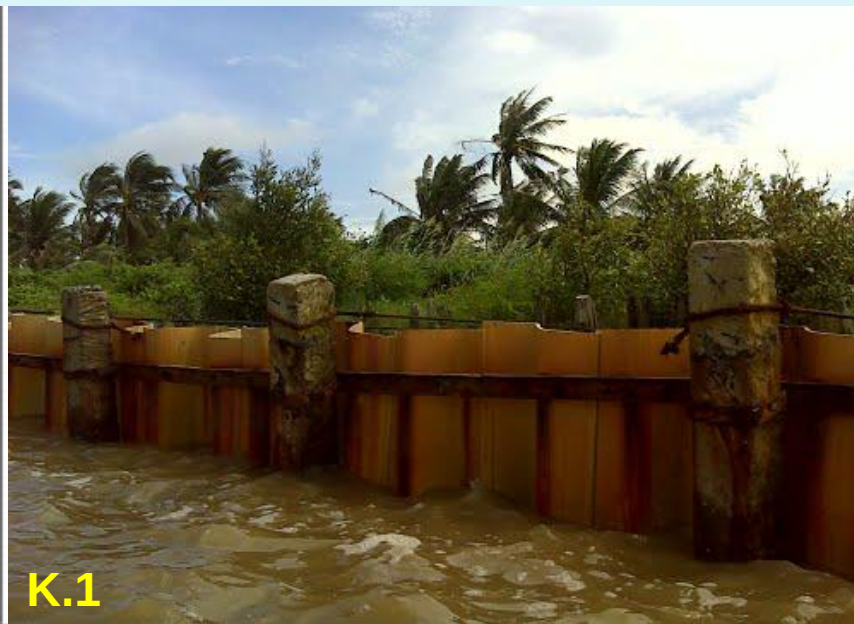
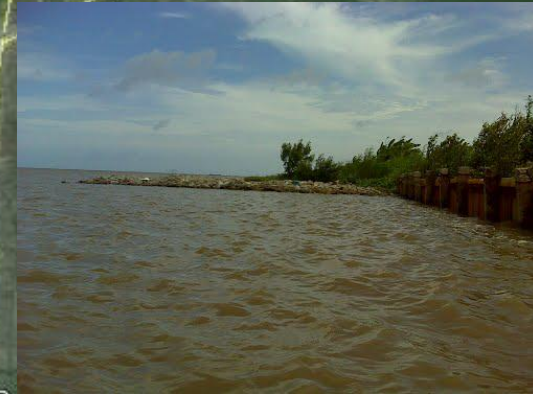
## 5. Ca Mau- Khánh Hội- Concrete and plastic sheet pile. : L= 1.186 Km

**Observation: Protected from erosion ?, long term?**

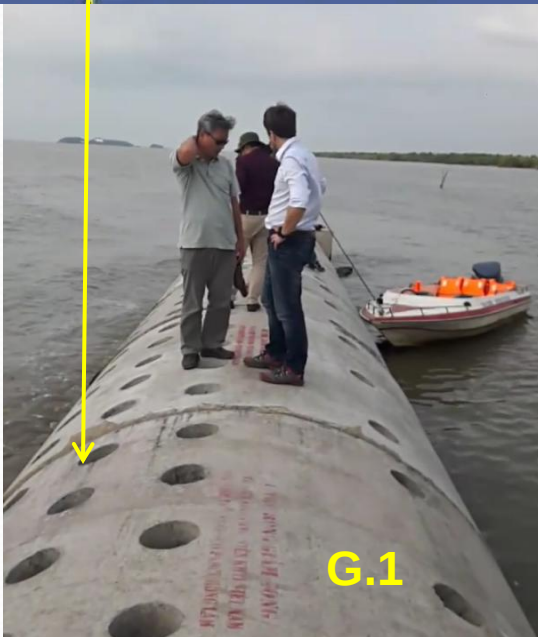
## 5. Ca Mau– Breakwater: Hon Da Bac : L= 160 m

**Observation : Effective deposition?, costly?**

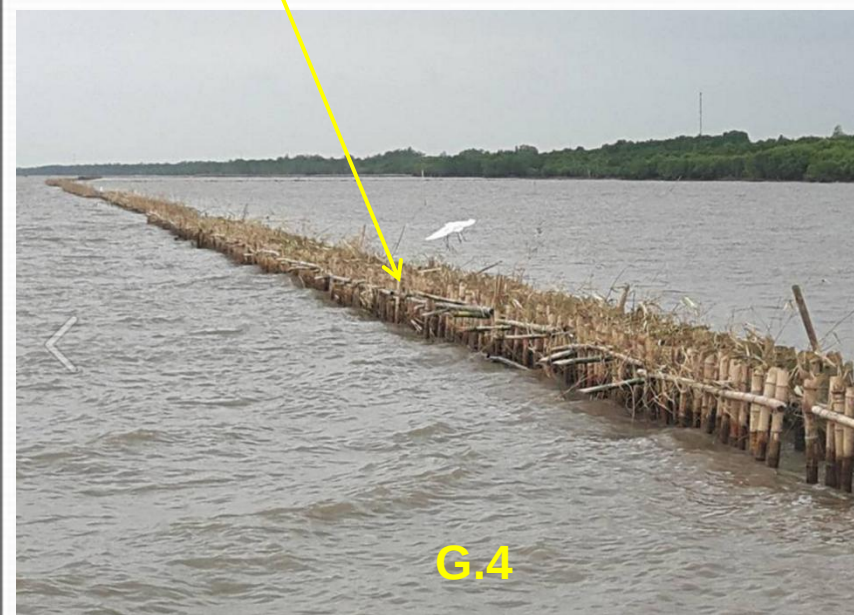
## 5. Ca Mau– Tran Van Thoi (near Hon Da Bac : L= 2,300 km)

Bamboo fence at Tran Van Thoi District, length of 2.3km, 18 billions VNĐ (340 USD/m), WIP design....construction December 2015, not yet trapping enough sediment for afforestation, maintenance many times

**Observation : Effective deposition?, long term?**

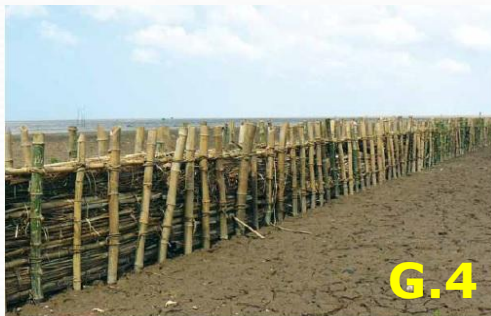
Tường phá/giảm sóng từ xa. **bằng cây**. tuyến thẳng

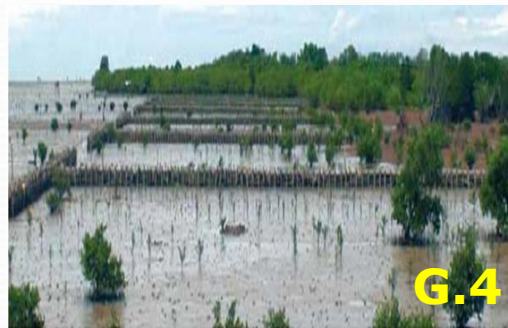
Tường ngầm phá/giảm sóng từ xa + giữ phù sa **bằng cây**. dạng chữ T

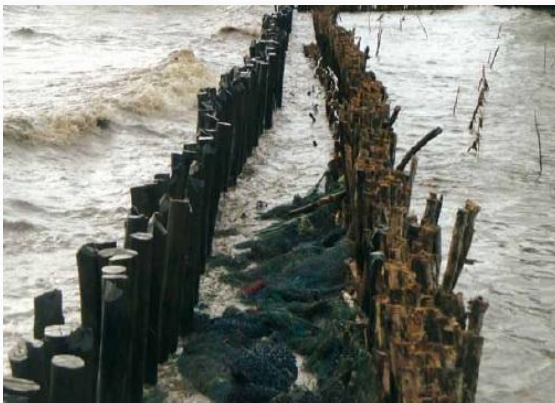
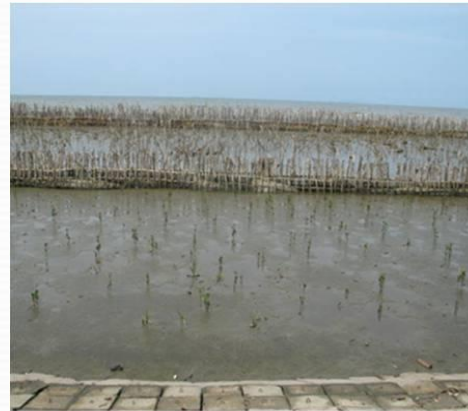
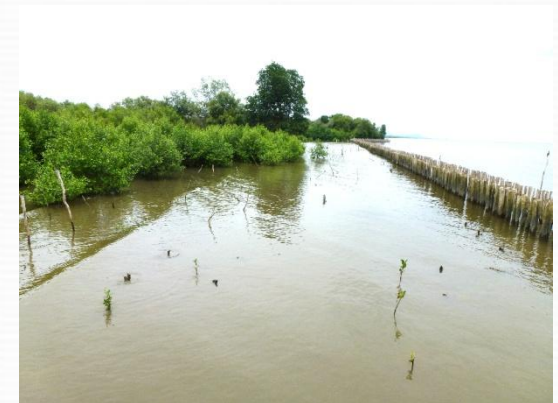
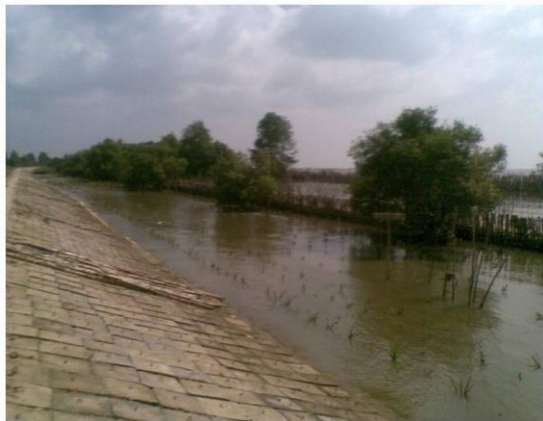
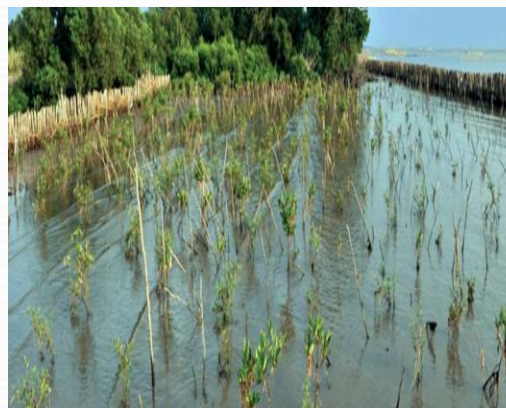
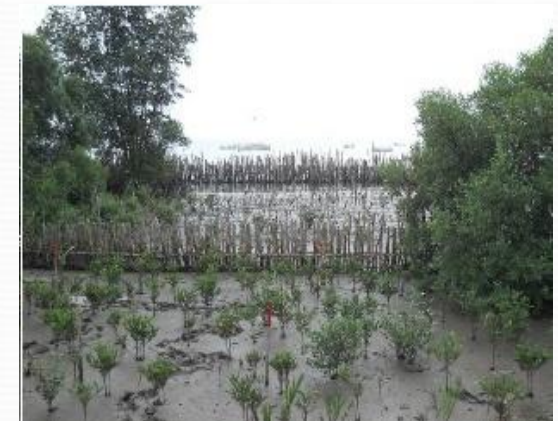
Hàng rào bằng cọc tràm. giảm sóng. dòng chảy ở Kiên Giang

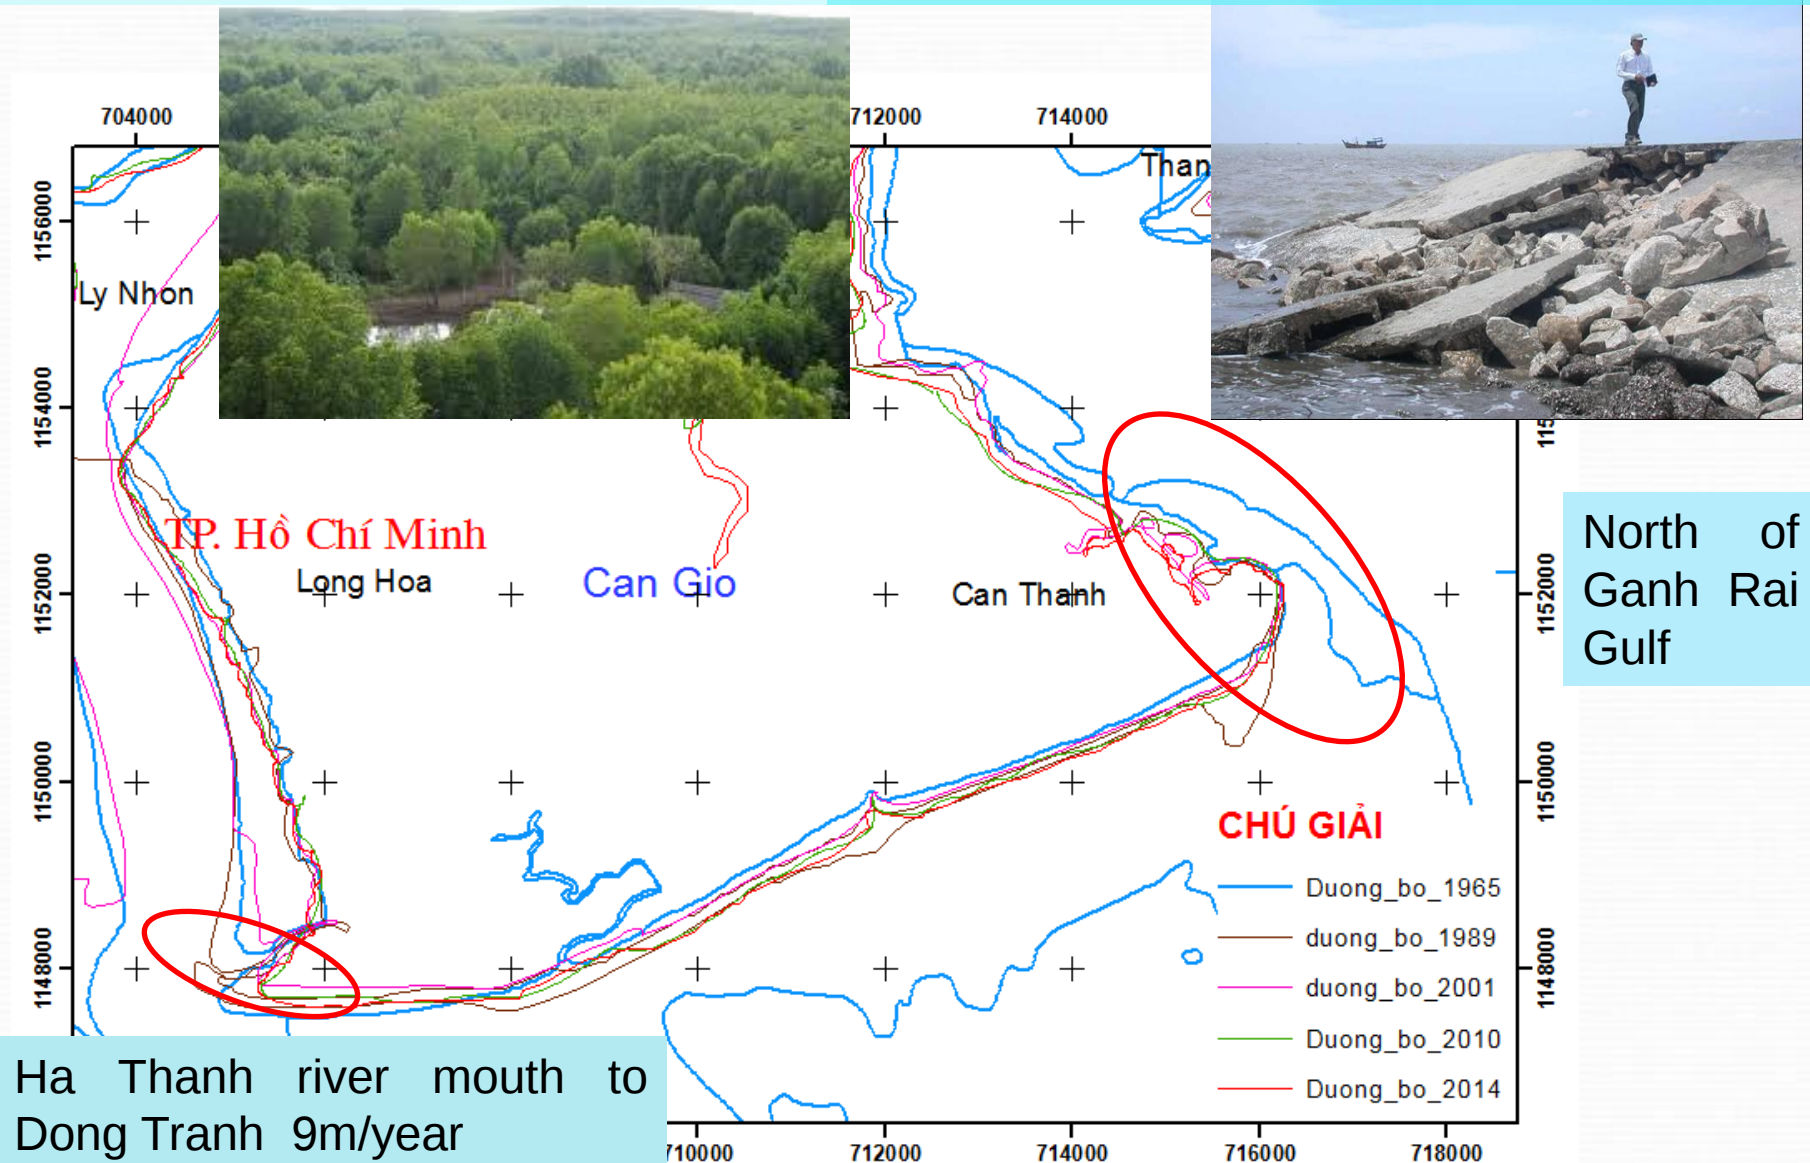
Ho Chi Minh City, period 1965-2014

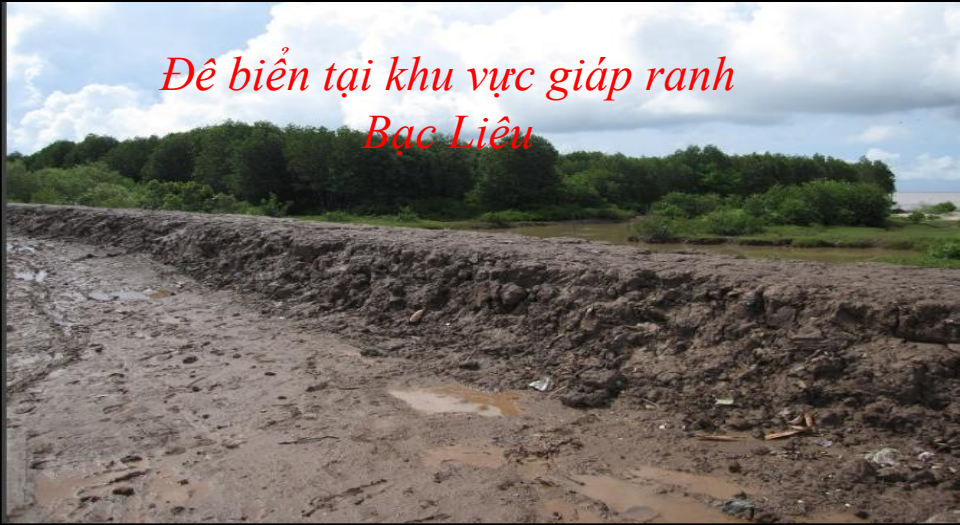
Đê biển tại khu vực giáp ranh Bạc Liêu

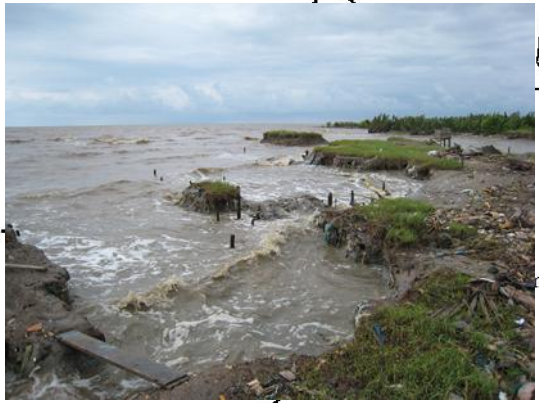
Khu vực xói  
bồi xen kẽ  
từ Mũi Cà  
Mau rạch  
Dừa đến  
Tiểu

Mũi Cà  
Mau. tốc  
độ bồi tụ  
80m/năm

Khu vực cửa sông  
Bồ Đề có tốc độ  
xói mạnh nhất  
40m/năm.

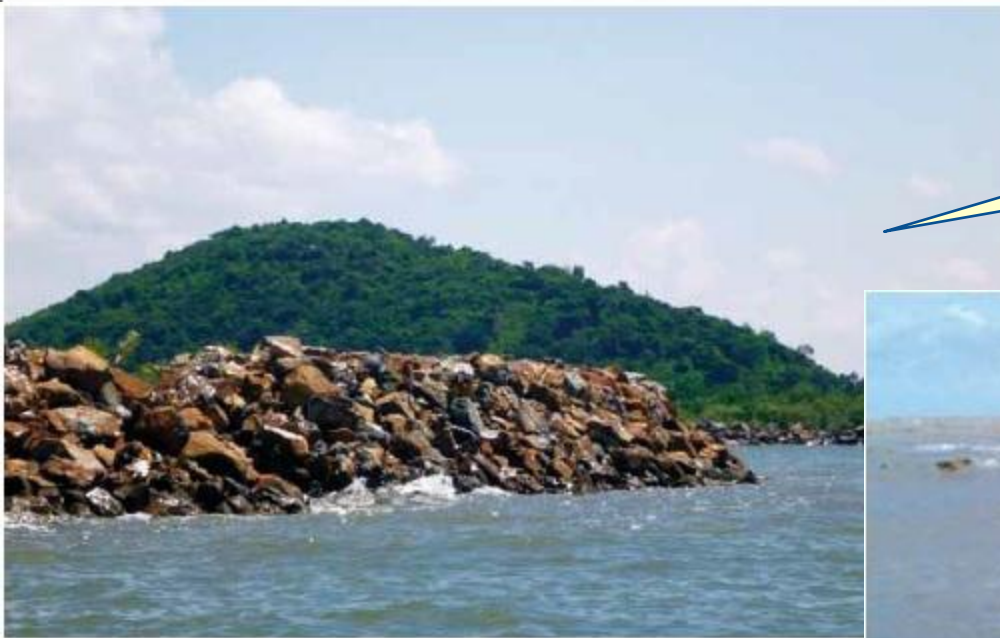
*Đê chắn sóng bằng đá đổ tại Hà Tiên tỉnh Kiên Giang*

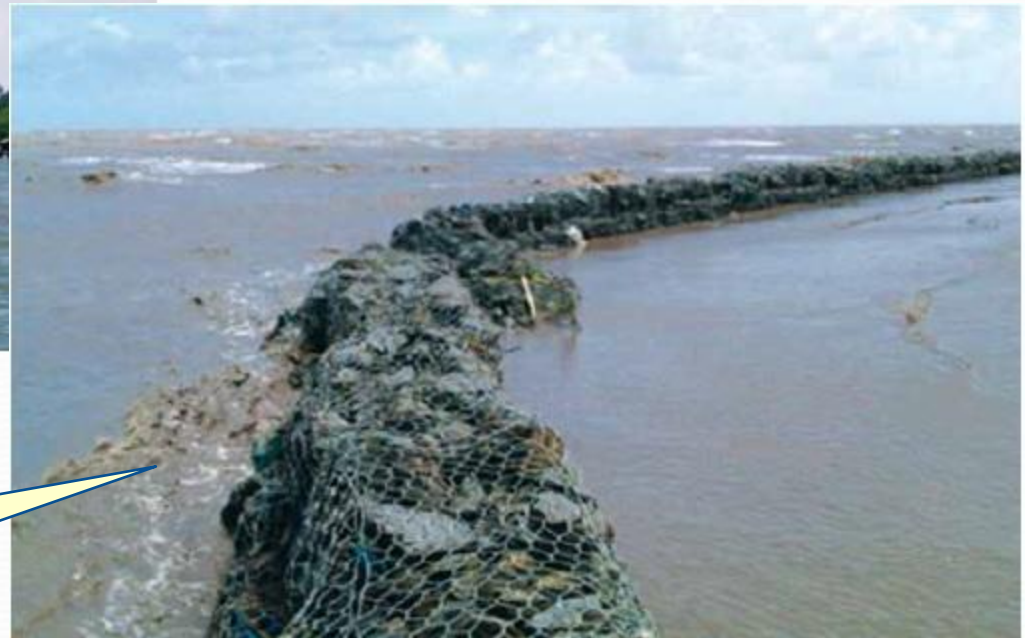
*Đê chắn sóng tách rời bao gồm các rọ đá tại bờ biển Tây. tỉnh Cà Mau*

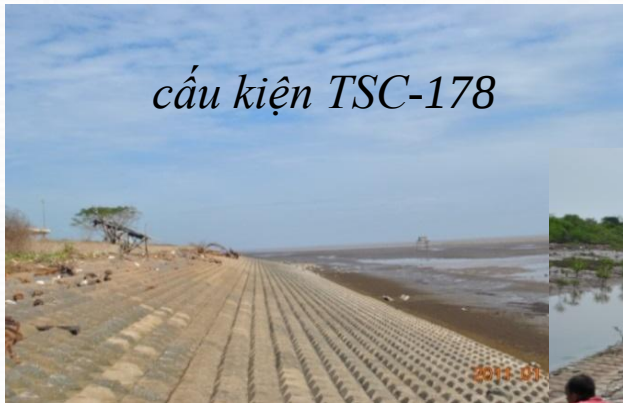
*Tổng chiều dài của đoạn kè này là: 3km*

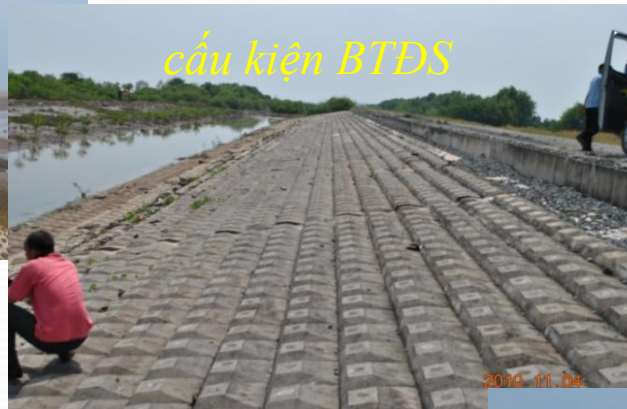
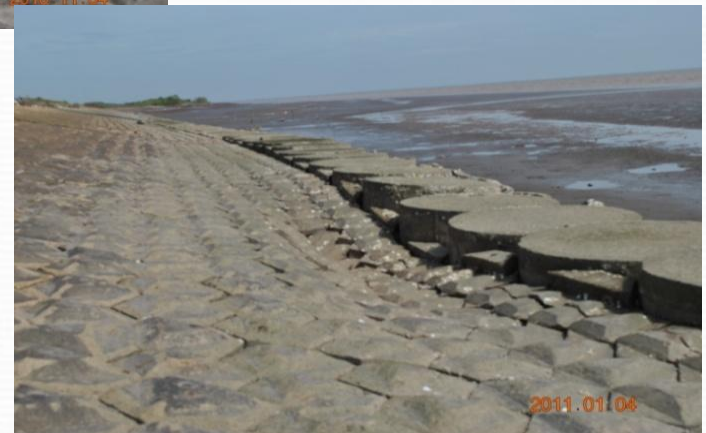
Dưới tác động của sóng biển. chân kè tại một số đoạn khác xuất hiện hiện tượng **sụt lún chân kè**. hàng chân khay ống buy gia cố cũng bị mất ổn định đe dọa ổn định chung của kè

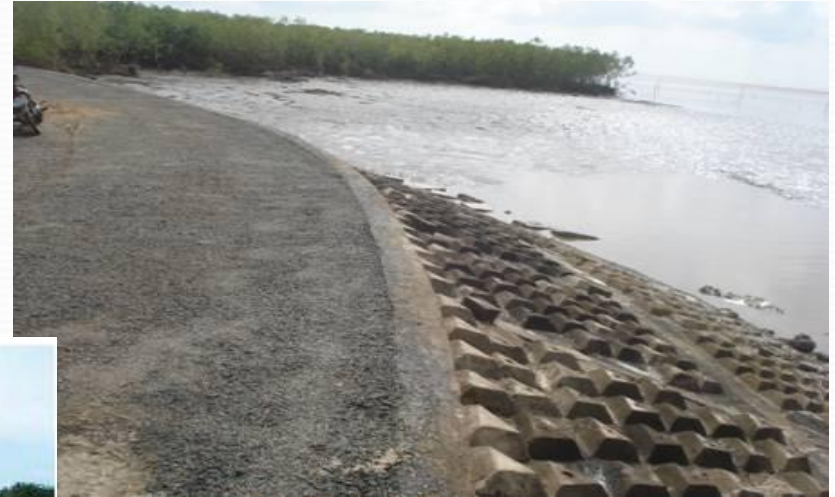
*Kè bê tông khu du lịch Nhà Mát*

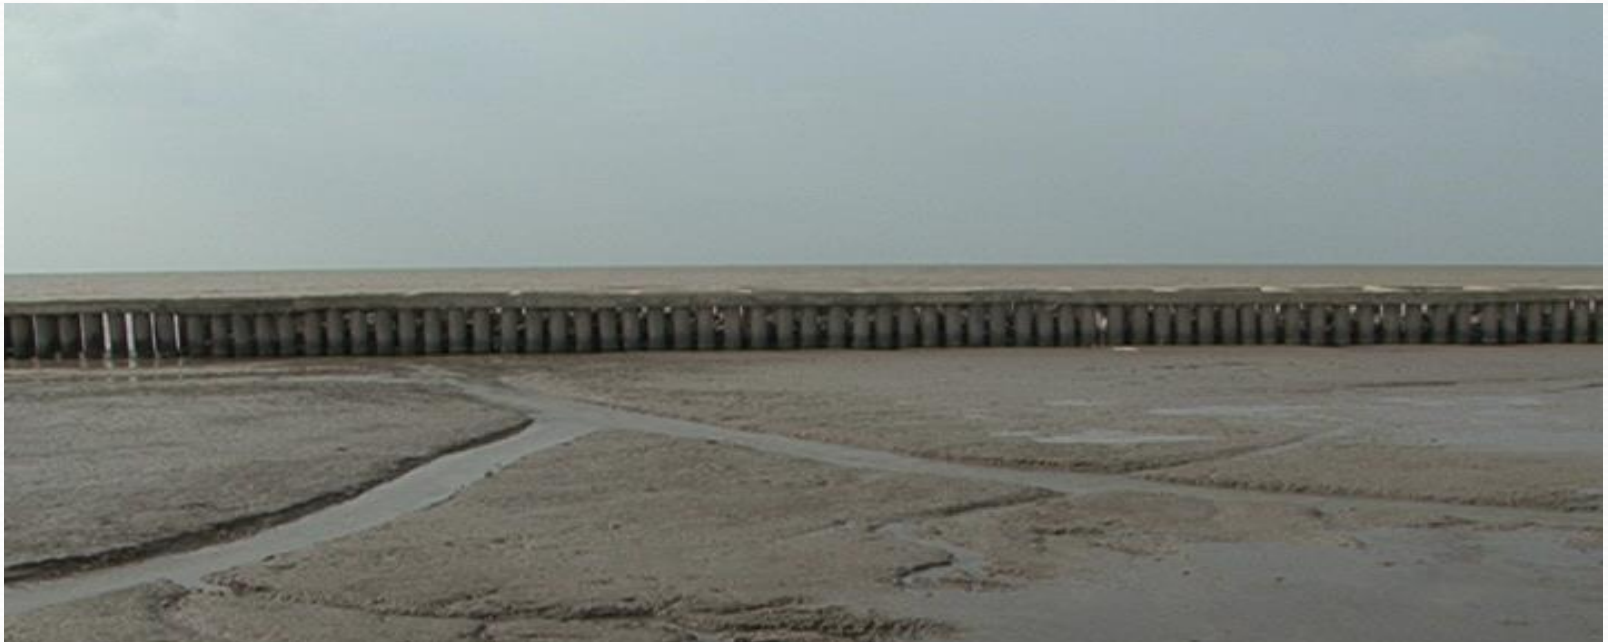
Năm 2011. tỉnh Cà Mau thử nghiệm 300m kè ly tâm tại xã Khánh Tiến huyện U Minh. Bước đầu cho kết quả tốt

- Tuy nhiên cần thời gian để đánh giá hiệu quả. mức độ ổn định của kè;
- Kinh phí 30-40 tỷ/km. chiều dài tuyến 2012 là 1.5km
- Thân thiện môi trường?

*Gây bồi tạo bãi trên đê biển Tây bằng kè ly tâm chắn sóng*

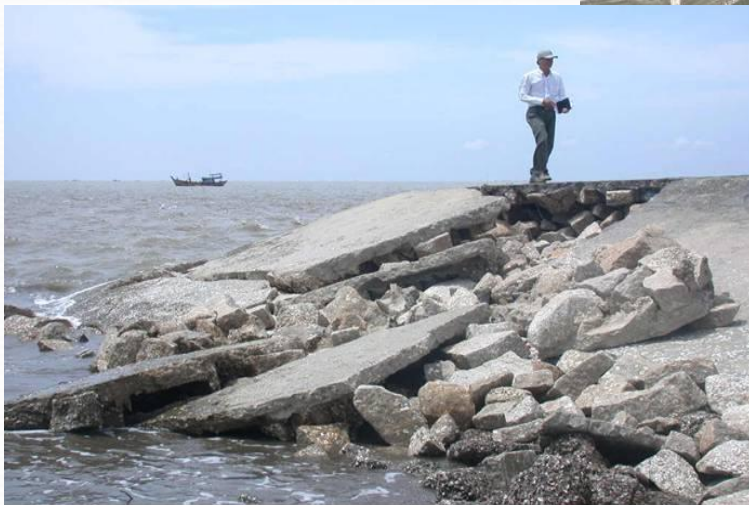
*Nhìn chung toàn tuyến kè hiện tương đối ổn định. nhiều vị trí kè được bồi lắng. tuy vậy cũng có một vài đoạn đang bị sạt lở*

*Sạt lở bờ kè và các mở hàn gần cửa sông  
Sòai Rạp huyện Cần Giờ*

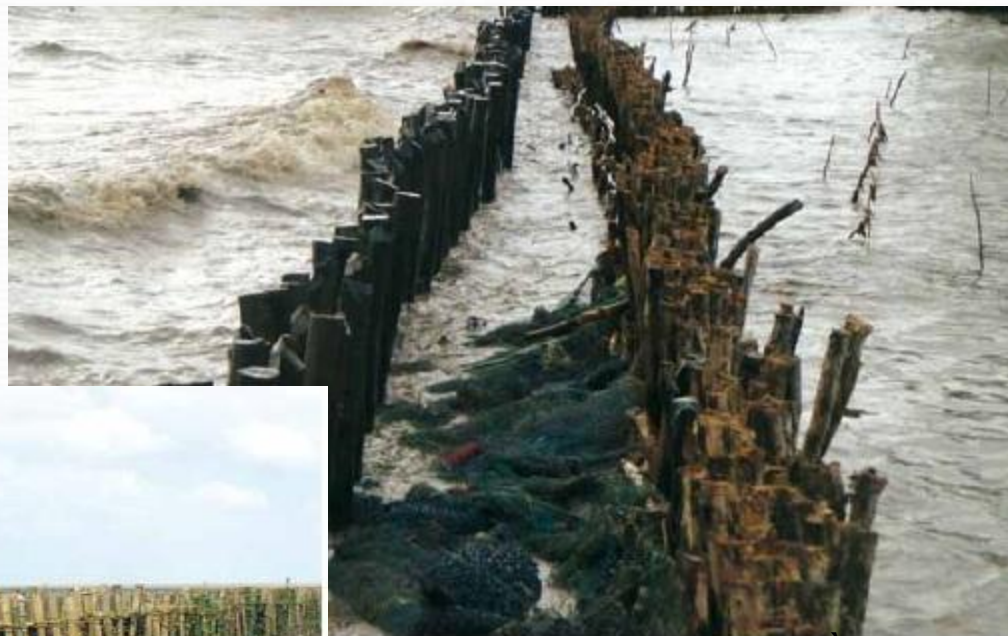
*Hàng rào phá sóng bằng cừ tràm ở Kiên Giang*

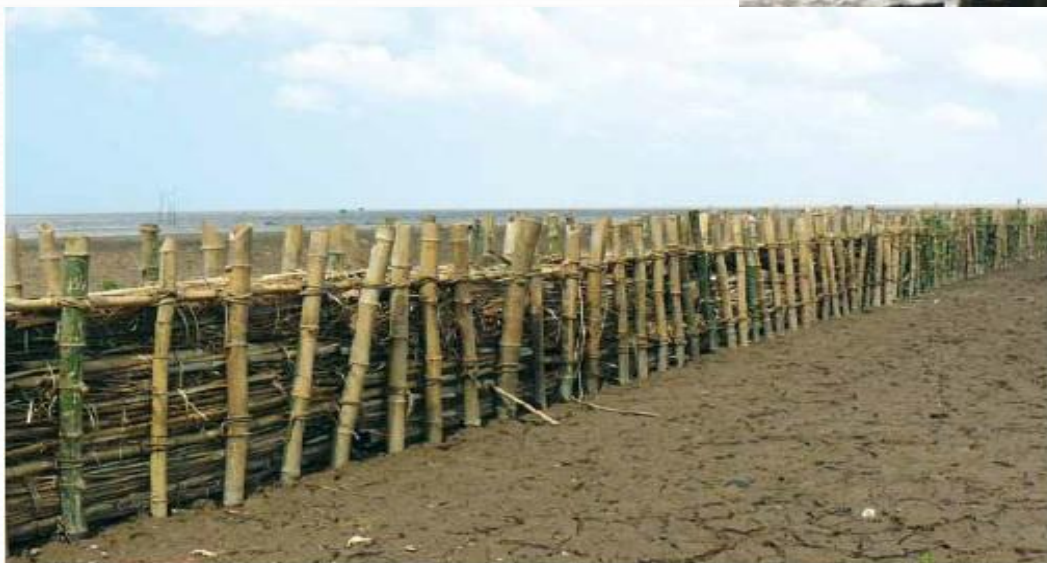
*Hàng rào tre phá sóng tại Vĩnh Tân tỉnh Sóc Trăng*

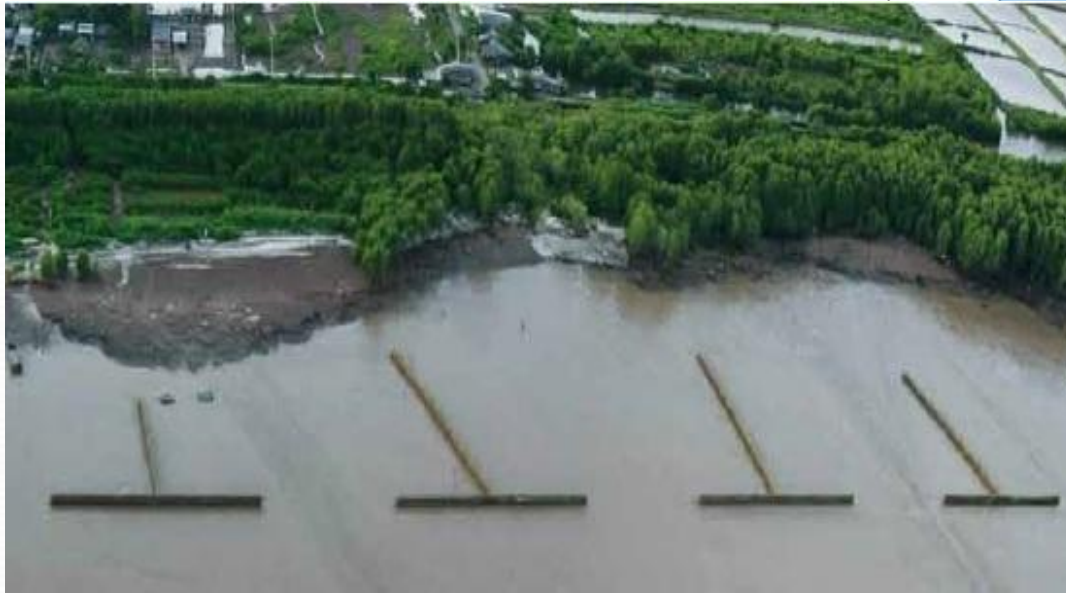
*Hàng rào tre chữ T trên bờ biển tỉnh Bạc Liêu*
